# Big and Sagabeard Creeks Fish Passage

OWEB Project # 212-2016 Project Monitoring Report - Year Two Exhibit D

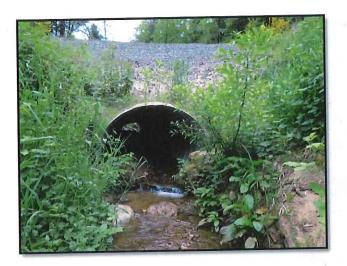
Figure 1a. Looking upstream at the Big Creek Culvert.

Pre-project: 2/11/2011

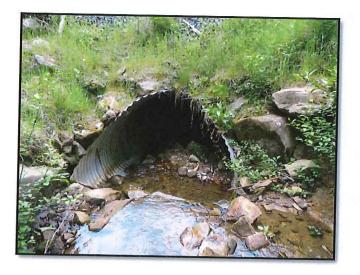
Figure 2a. Looking downstream at the Big Creek culvert.

Pre-project: 2/11/2011

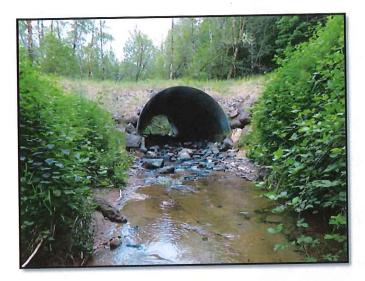
Figure 3a. Looking upstream at the culvert proposed for replacement on Sagabeard Creek.

Pre-project: 11/11/2011

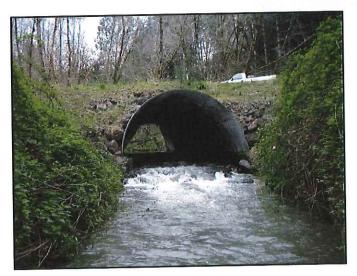
Figure 3c. Looking upstream at the Sagabeard Creek culvert.

Lutsinger Creek Road has a moderate amount of traffic, but has held up nicely since the culvert was replaced.

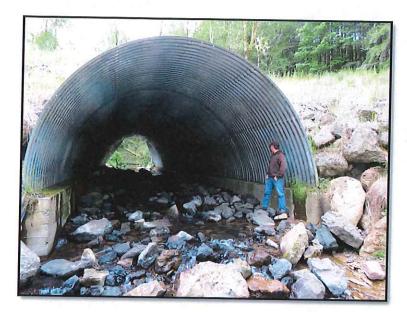
**Figure 4a.** A close-up view of the Sagabeard Creek culvert.

Note the large size of the culvert. This is a significant watershed and the small original culvert produced a velocity barrier during higher flows. This is no longer an issue. Also note the natural stream bottom in the arch culvert.
