Partnership for the Umpqua Rivers

Morgan Creek Restoration

OWEB Project # 210-2061 Project Monitoring Report – Year Three June 24, 2015

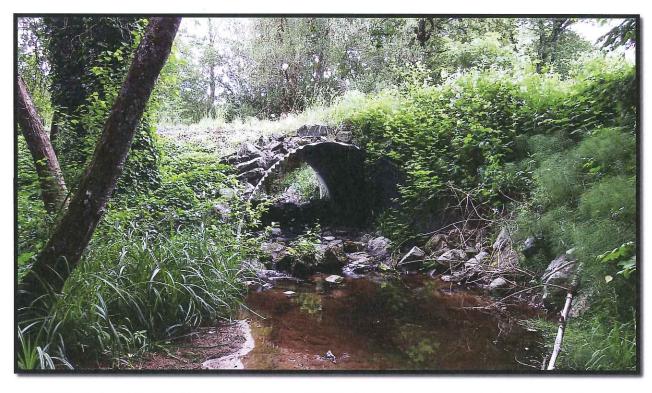
Battle Culvert Outlet Post-project June 2015. Culvert continues to function well.

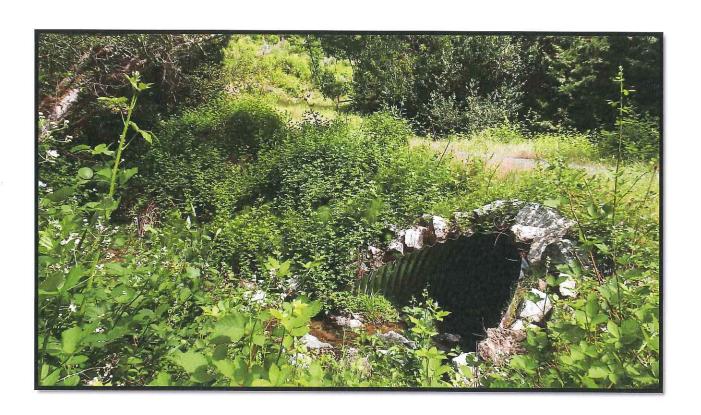
Briggs Culvert Inlet Post-project June 2015. The site is stable and passing all fish.

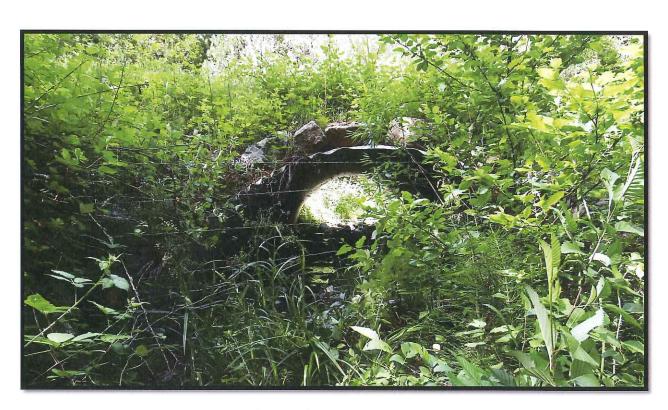
Briggs Culvert Outlet
Post-project June 2015. Vegetation, including small alders, have vegetated all the disturbed areas around the culvert replacement.

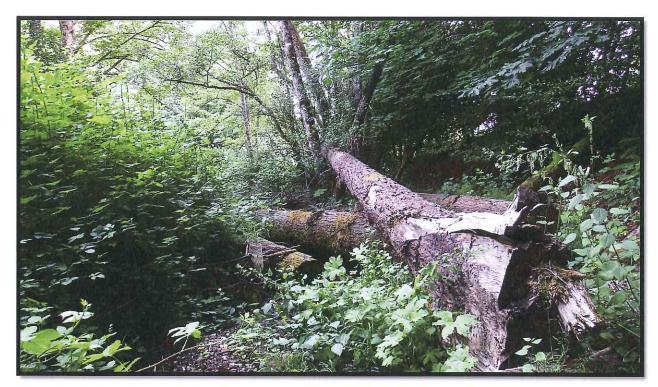
Site #11 Briggs Property Post-project June 2015. These logs transformed this reach by increasing meander and increasing pool depth, huge physical changes to occur in only five years.

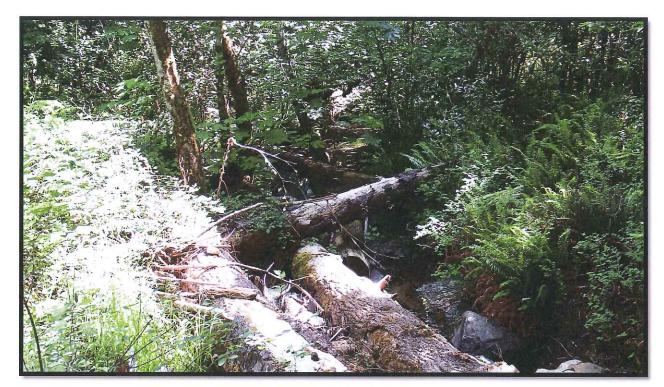
Site #12 Briggs Property Post-project June 2015. Utilizing large materials in a small stream provided a fast stream response to the treatment. Complexity, cover, and increased interaction with the floodplain increased soon after the materials were placed.

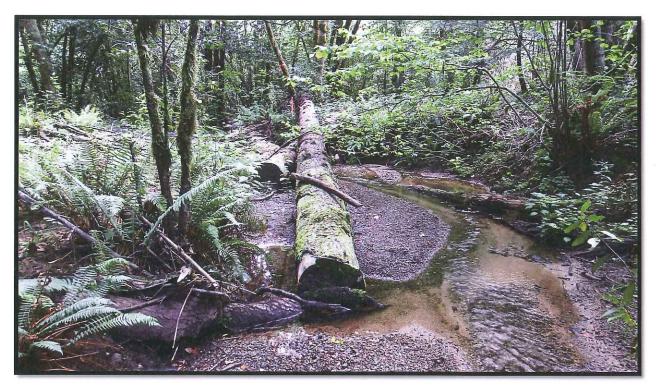
Site #15 Briggs Property Post-project June 2015. Laying large materials in the creek created meanders, islands, side channels, and deeper pools.

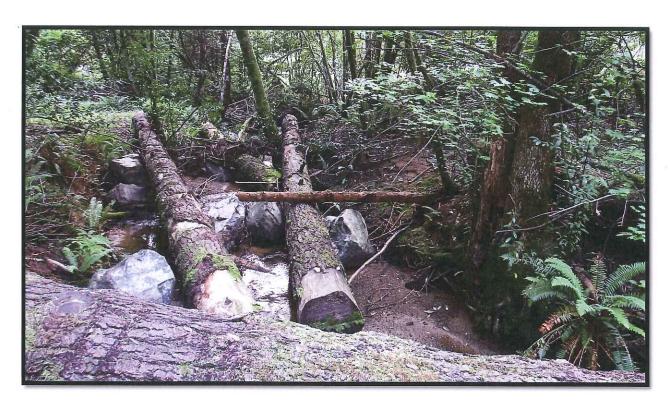
Site #21 Briggs Property Post-project June 2015. Sand deposits are seen far up into the floodplain after the Dec. 21st, 2014 storm came through. This high water event was estimated to be a 20 year return interval event. The logs held firm in this flow and complexity continues to increase with increased gravel and sand deposition.

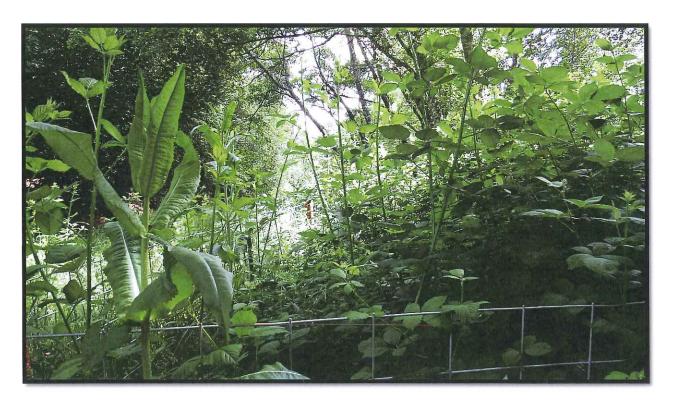
Riparian Exclusions and Plantings June 2015. The owner was unable to maintain the exclusions and the blackberry around them. Once livestock were off the pasture, the blackberry had no disturbance and grew freely.
