**Project Manager Report Review Protocol
Post-Implementation Status, Interim Progress, and Quarterly Reports**

Waggoner Creek Instream Restoration

OWEB Project # 212-2013-8856

Project Monitoring Report – Year Two

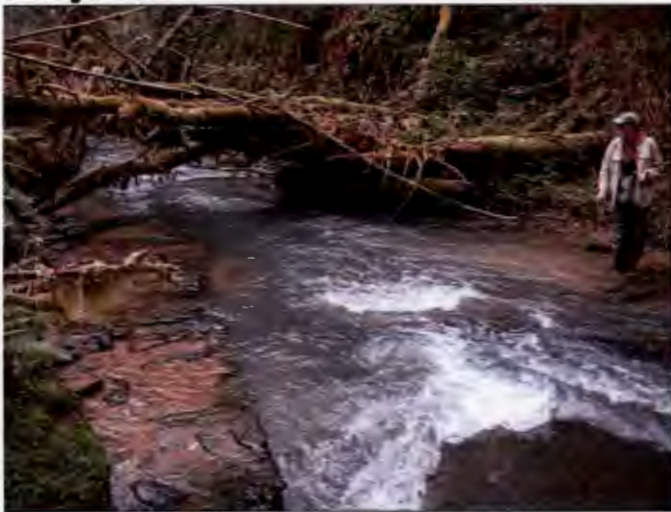
Project Site 11

Figure 1a. Looking downstream at site 11.
Pre-project: 3/15/2011

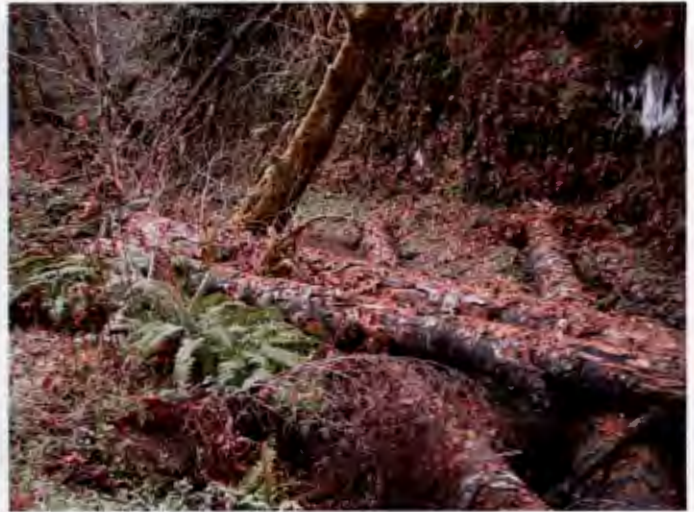
Figure 1b. Looking downstream at site 11.
Post-project: 12/19/2013

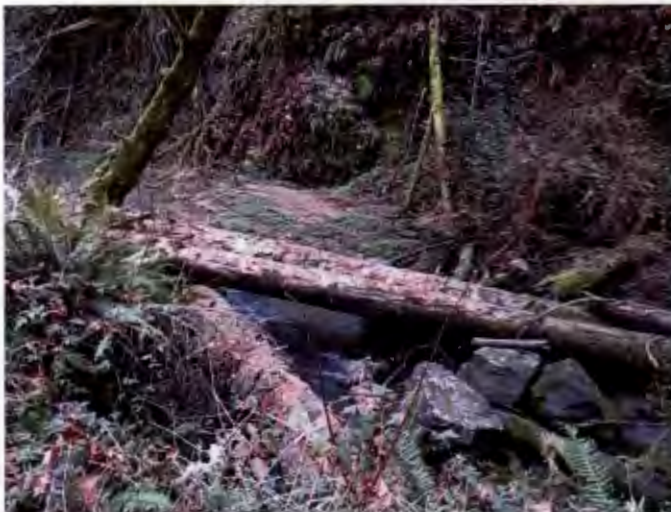
Figure 1c. Looking downstream at site 11. Two logs were washed out of the site during high water, but both were captured in the next site downstream.
Post Project 2/15/2016

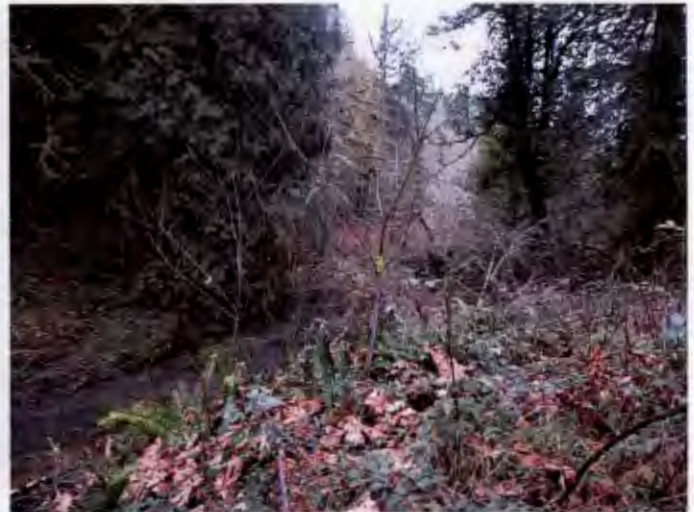
Figure 1d. Site 11 looking upstream. Alders and willows are growing nicely in the riparian access corridor.
Post-Project: 2/15/2016

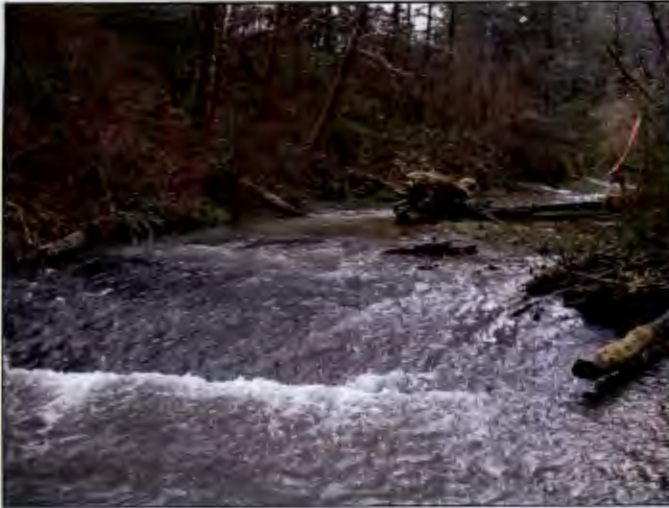
Project Site 20

Figure 2a. Looking upstream at site 20.
Pre-project: 3/15/2011

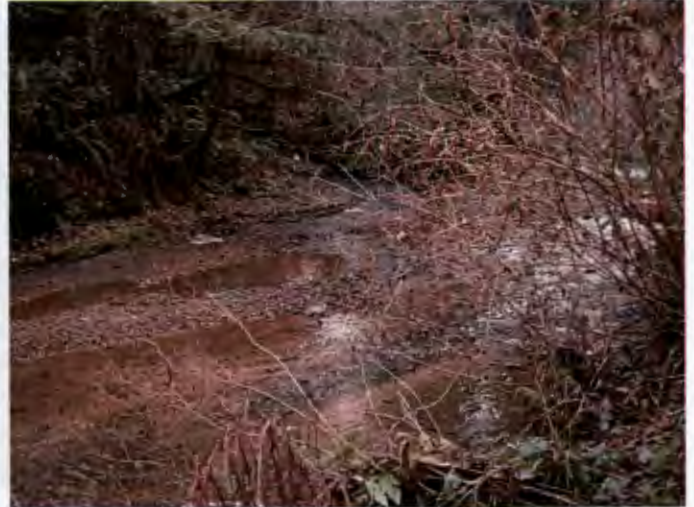
Figure 2b. Looking upstream at site 20.
Post-project: 12/19/2013.

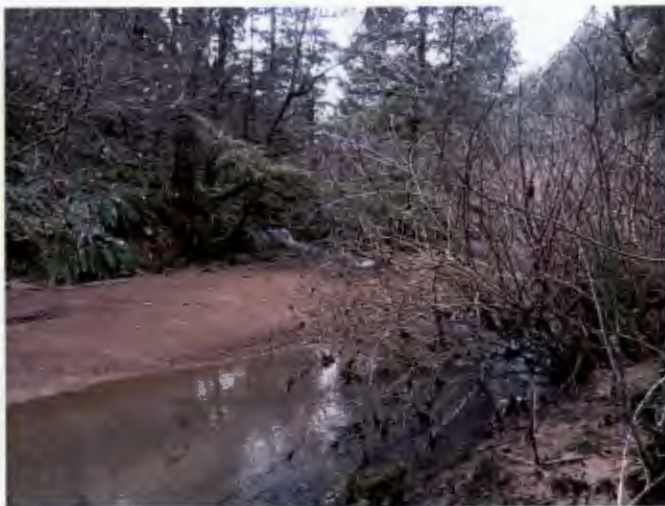
Figure 2c. Site 20 looking upstream.

Massive amounts of gravel have accumulated above the site, which was strategically located just below a small tributary (center of photo).

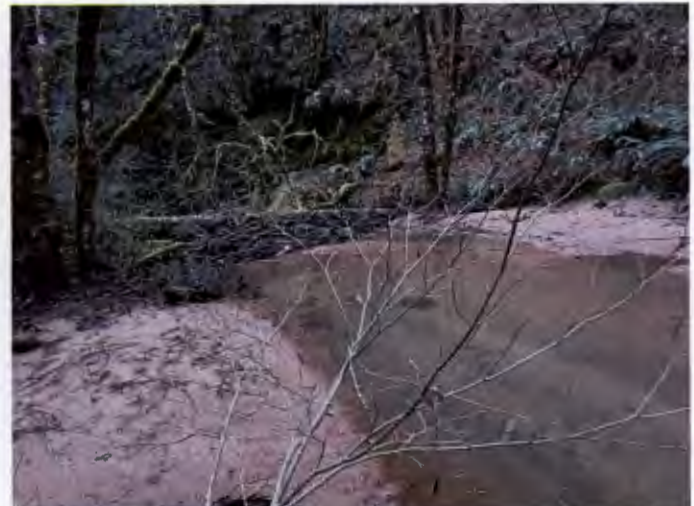
Figure 2d. Site 20 looking downstream.

Fine material has also accumulated above the site.

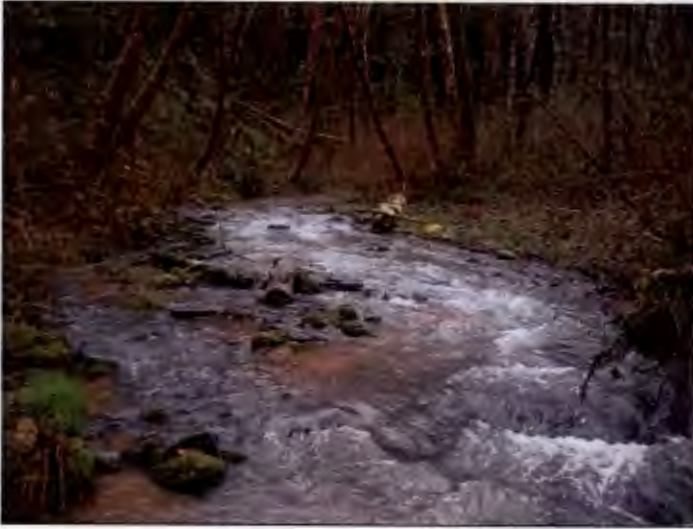
Project Site 33

Figure 3a. Looking upstream at site 33.

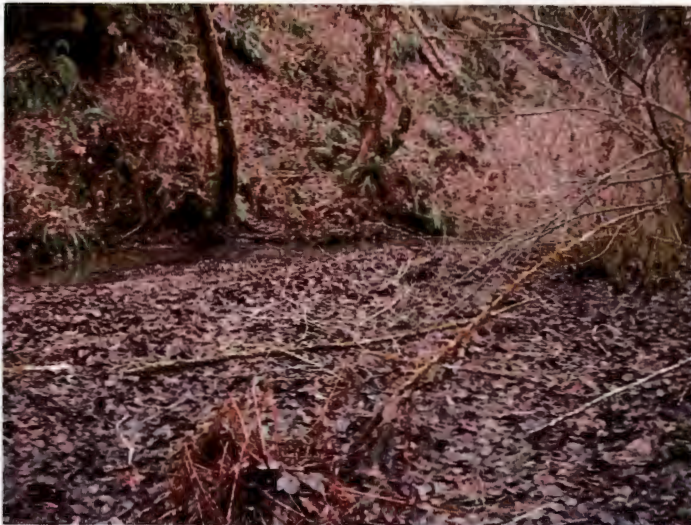
Figure 3b. Looking upstream at site 33.

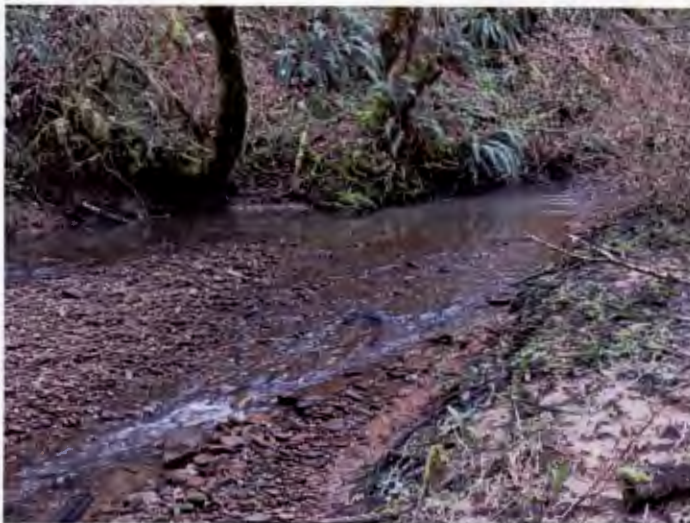
Figure 3c. Looking upstream of site 33.

This reach was bedrock-dominated prior to implementation. Gravel has accumulated here and now it is an excellent spawning area.

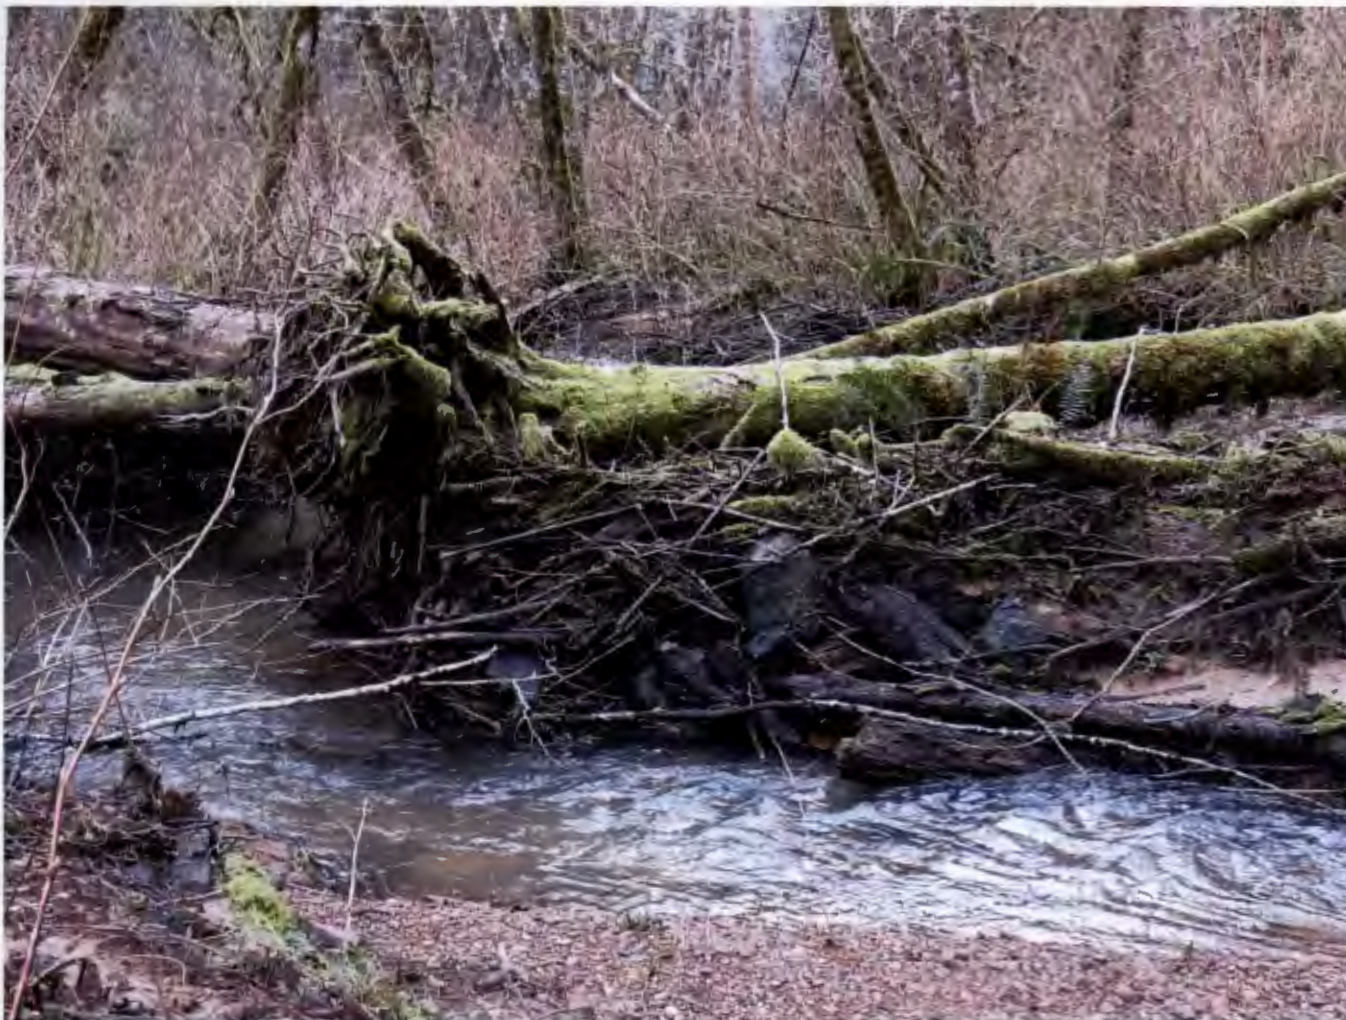
Project Site 6

Figure 4. Site 6, looking downstream. This large alder with rootwad fell into the stream channel and was lodged into the site, further strengthening the structure.
