## Weatherly Creek Instream Restoration

OWEB Project # 212-2064-9341

Project Monitoring Report – Year Two

Prepared By  
Partnership for the Umpqua Rivers  
February 24, 2016

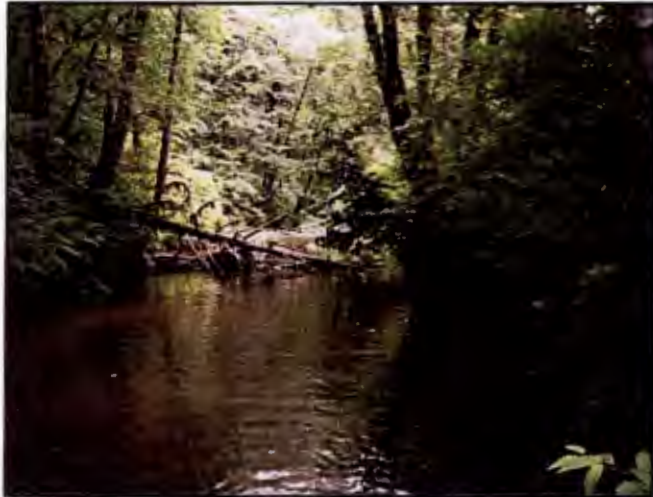
**Figure 1a.** Site 1, looking upstream.  
Pre-project: 7/20/2011

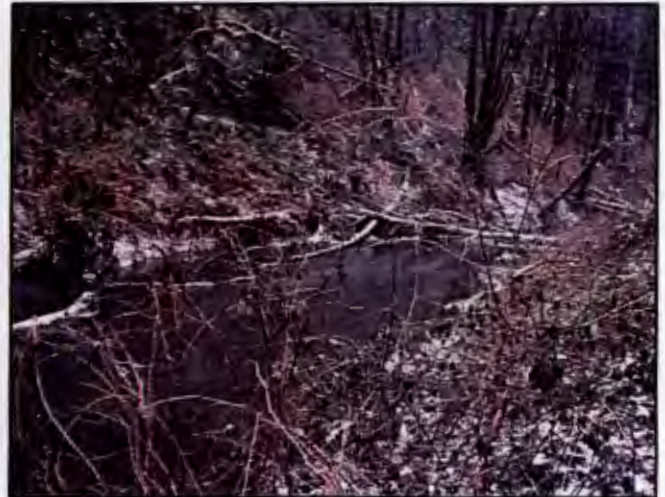
**Figure 1b.** Site 1, looking upstream.  
Post-project: 2/01/2014

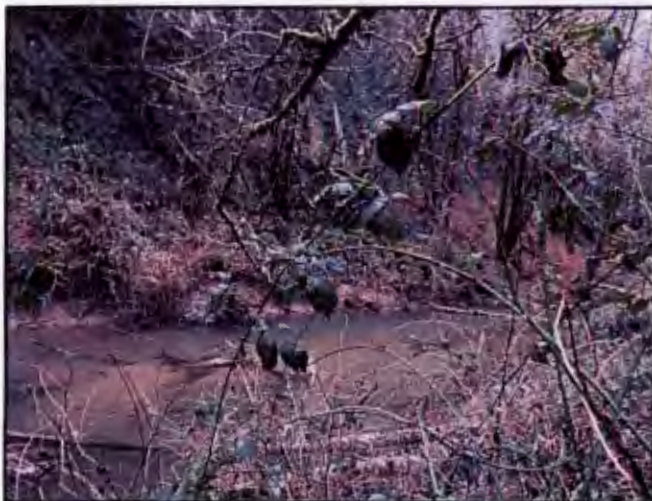
**Figure 1c.** Site 1, looking upstream.  
Post-Project: 2/15/2016

This is the lowest log/boulder site. Note how the water has pooled and fine sediments are dropping out.

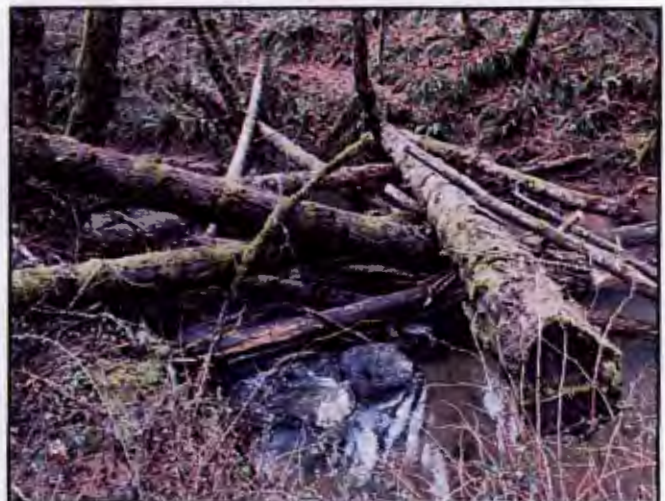
**Figure 1d.** Site 1, looking downstream.  
Post-Project 2/15/2016

The large log in the foreground was picked up and moved downstream about 10' during a high water event. Additional LWD has accumulated on the site.

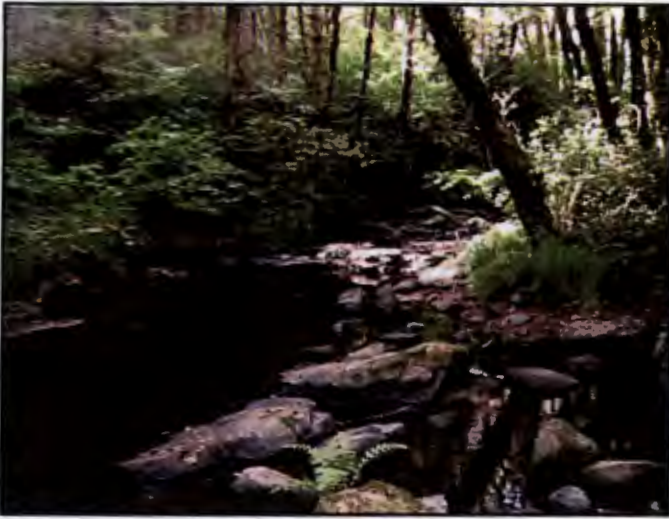
**Figure 2a.** Site 16, looking upstream.  
Pre-project: 07/20/2011

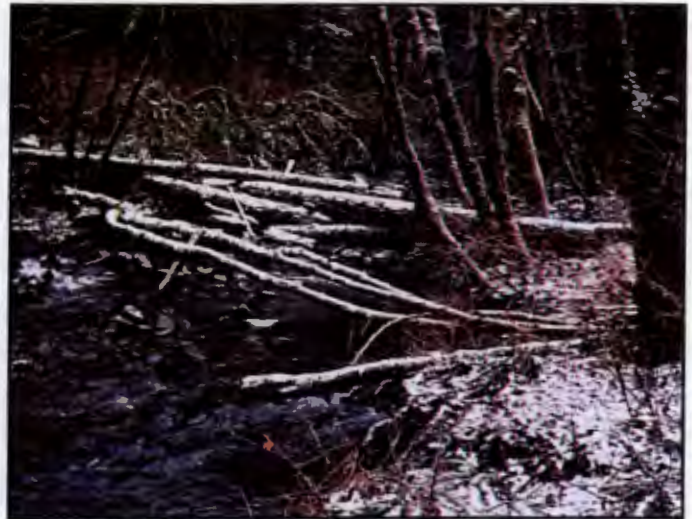
**Figure 2b.** Site 16 looking upstream.  
Post-project: 02/01/2014

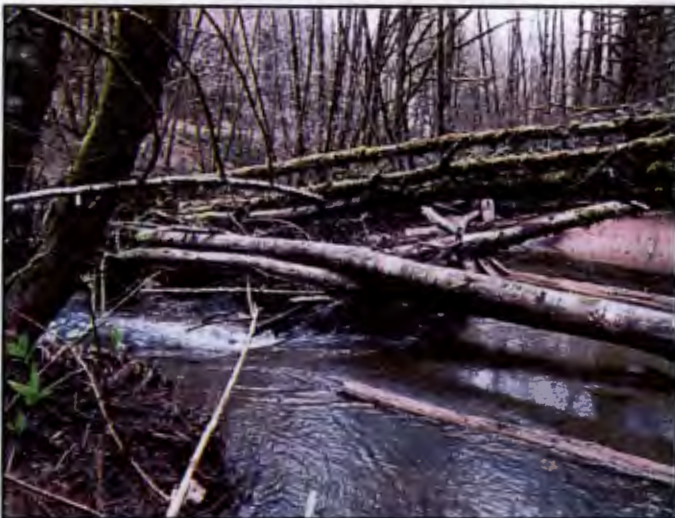
**Figure 2c.** Site 16, looking downstream. A large amount of additional large wood, in the form of riparian alders, has accumulated on the site.

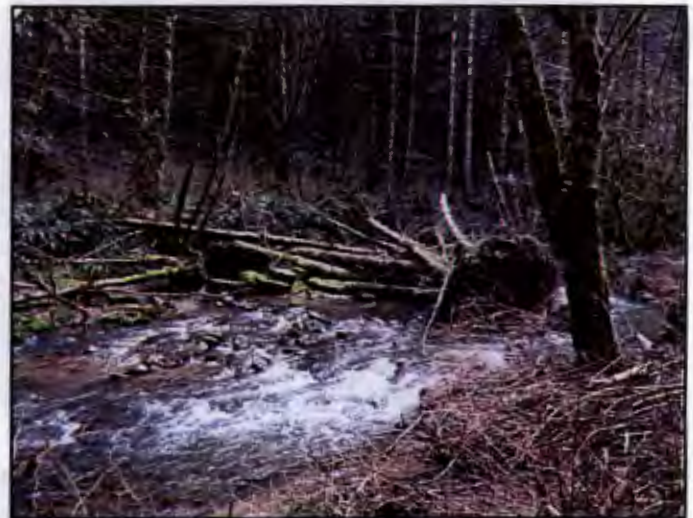
**Figure 2d.** Site 16, looking upstream. The complexity of the reach affected by this site has increased dramatically. Note the side-channel that has formed and increased sinuosity.

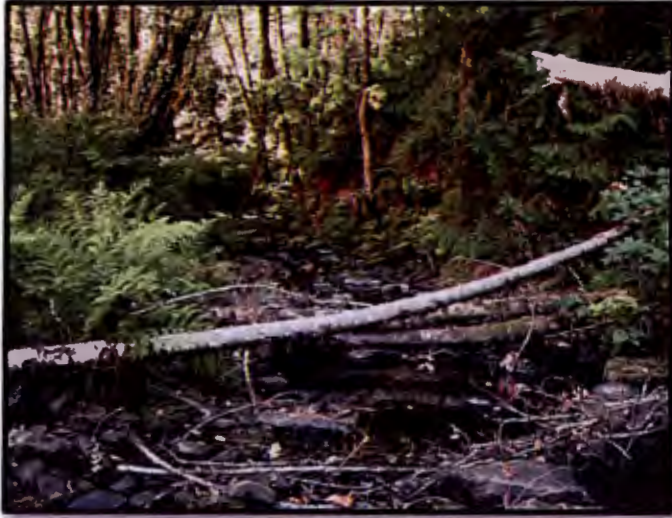
**Figure 3a.** Looking upstream at site East Weatherly 6.

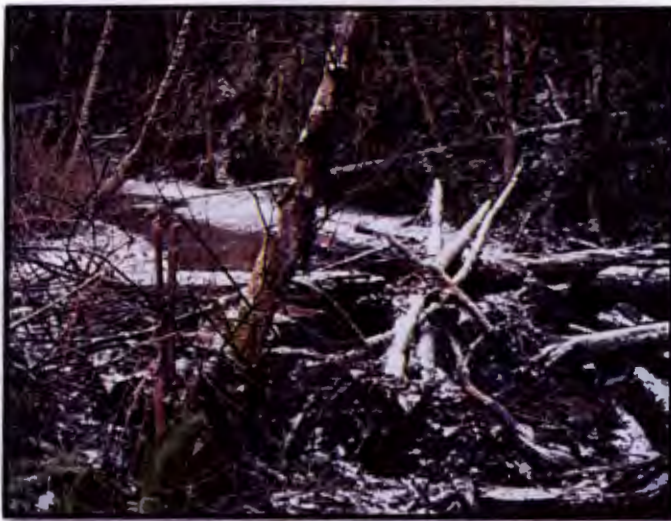
**Figure 3b.** Looking upstream at site East Weatherly 6.

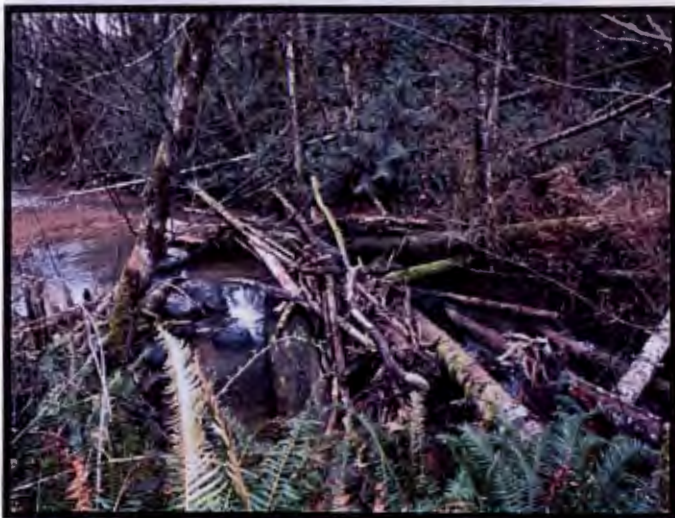
**Figure 3c.** Looking upstream at site East Weatherly 6.

This is the uppermost site on the project, and thus has accumulated the most additional LWD. Note the gravel bar above the site.
