# Partnership for the Umpqua Rivers

## Fate and Days Creeks Stream Restoration

OWEB Project # 210-2063

Project Monitoring Report – Year Three

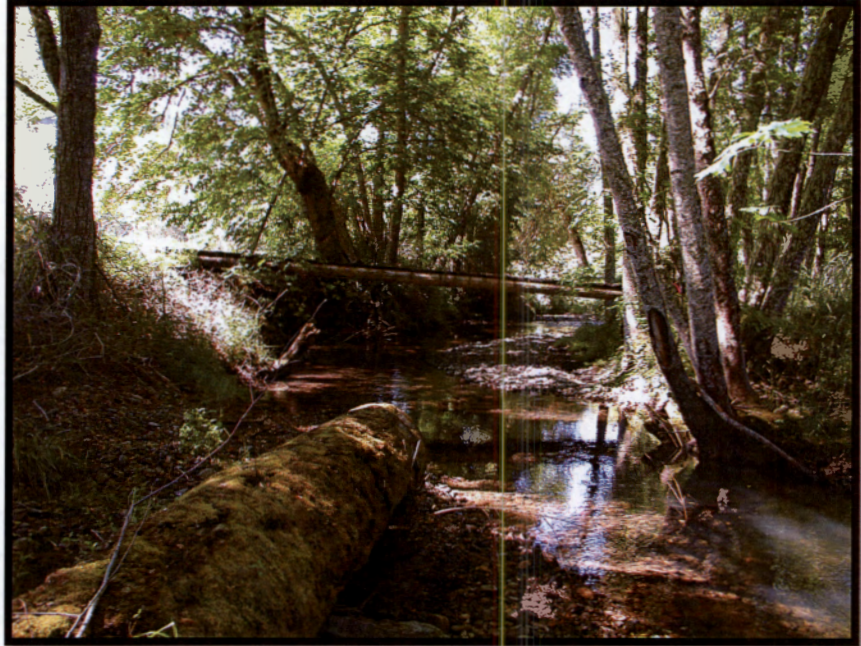
**Photo #1**

Days Creek Site 1

Pre Project

July 2010

The log in the foreground had moved from one of the first restoration efforts done in the county in the early nineties. It was relocated upstream and became part of a new log structure.

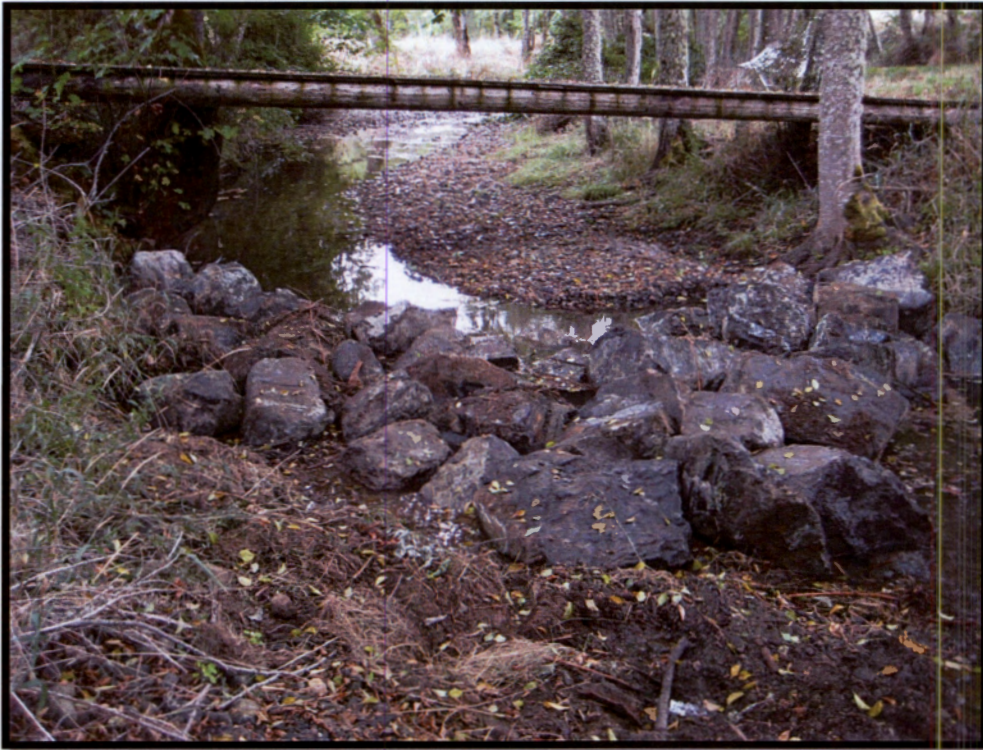
**Photo #2**

Days Creek Site 1

Boulder weir

September 2010

After project completion.

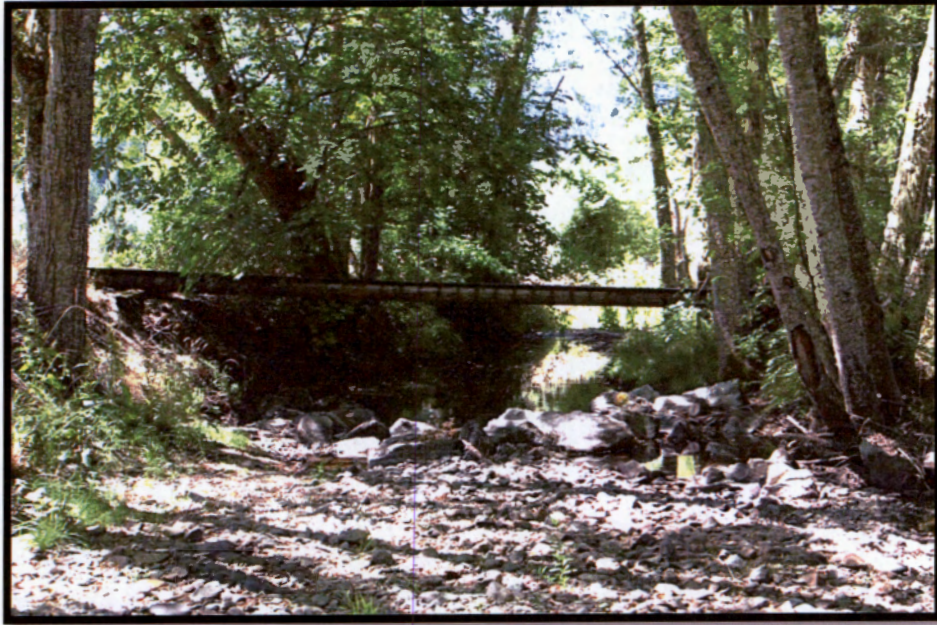
**Photo #3**

Days Creek Site 1  
The boulder weir has become imbedded with gravel substrate on the upstream side and has created a large pool on the downstream side that is still 4 foot deep when this photo was taken on July 27, 2013. There were many coho fry in the pool.

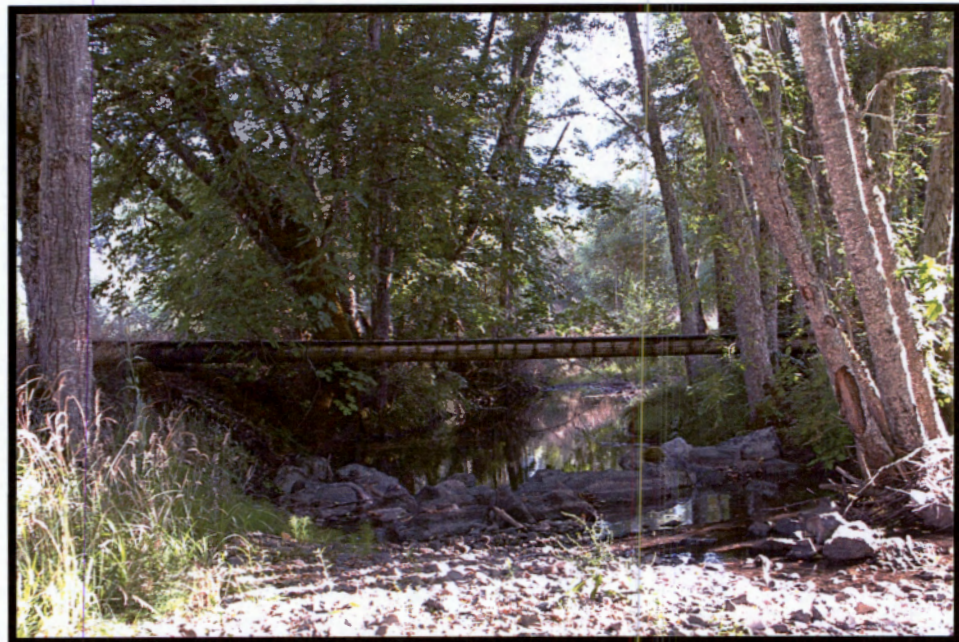
**Photo #4** Days Creek Site 1

Boulder weir is essentially unchanged since last year. Photo was taken July 27, 2014, the same day of the year as last year's photo. There was slightly more stream flow than last year even though the drought conditions in the county were worse. Again, Coho fry were seen in the downstream pool.

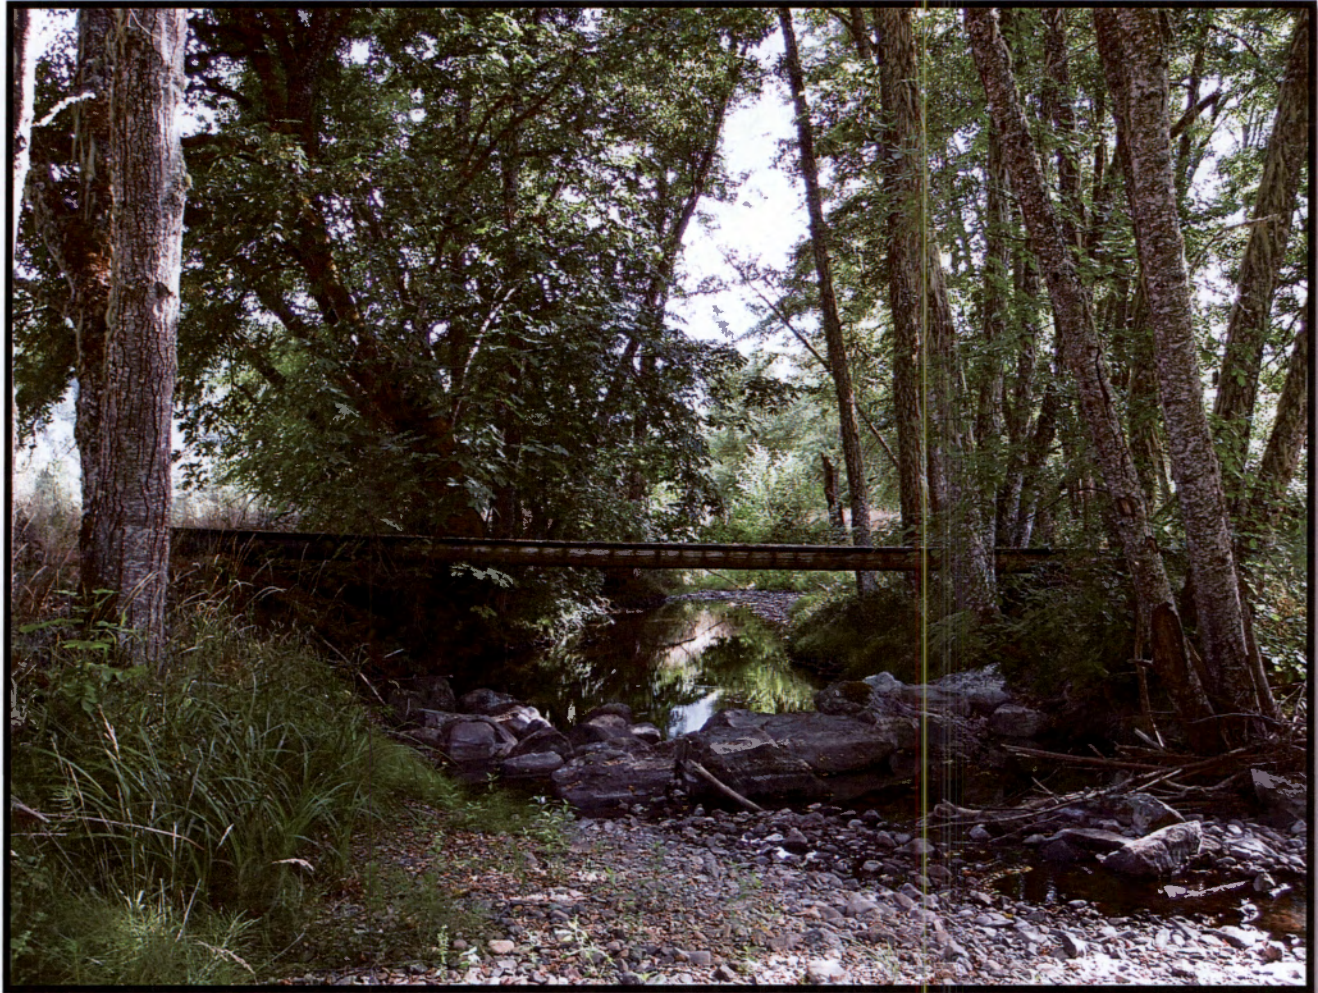
**Photo #5 Days Creek Site 1**

July 14, 2015 The boulders continue to aggrade gravel upstream and maintain deep scour pool downstream. Again coho fry are seen in the pool.

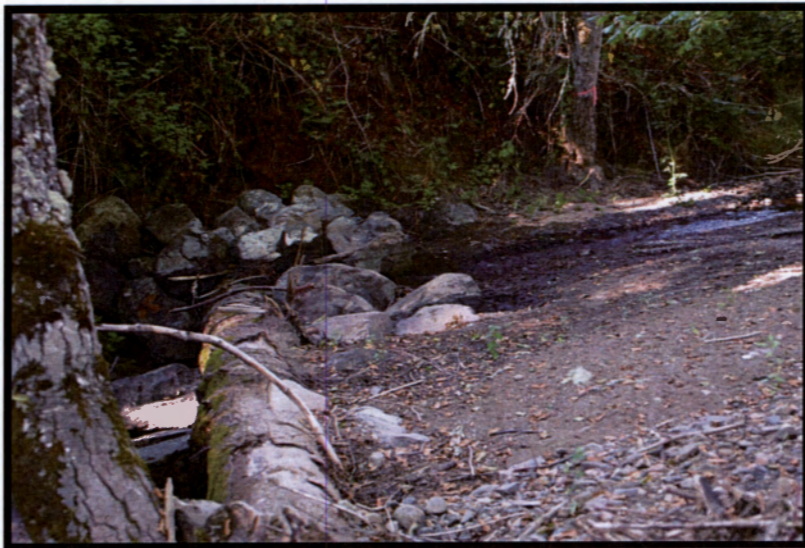
**Photo #9**

Days Creek Site 3

July 2014

The large amount of substrate that accumulated behind the log/boulder structure imbedding the boulders and log is still present and slightly deeper. The downstream pool contained coho fry.

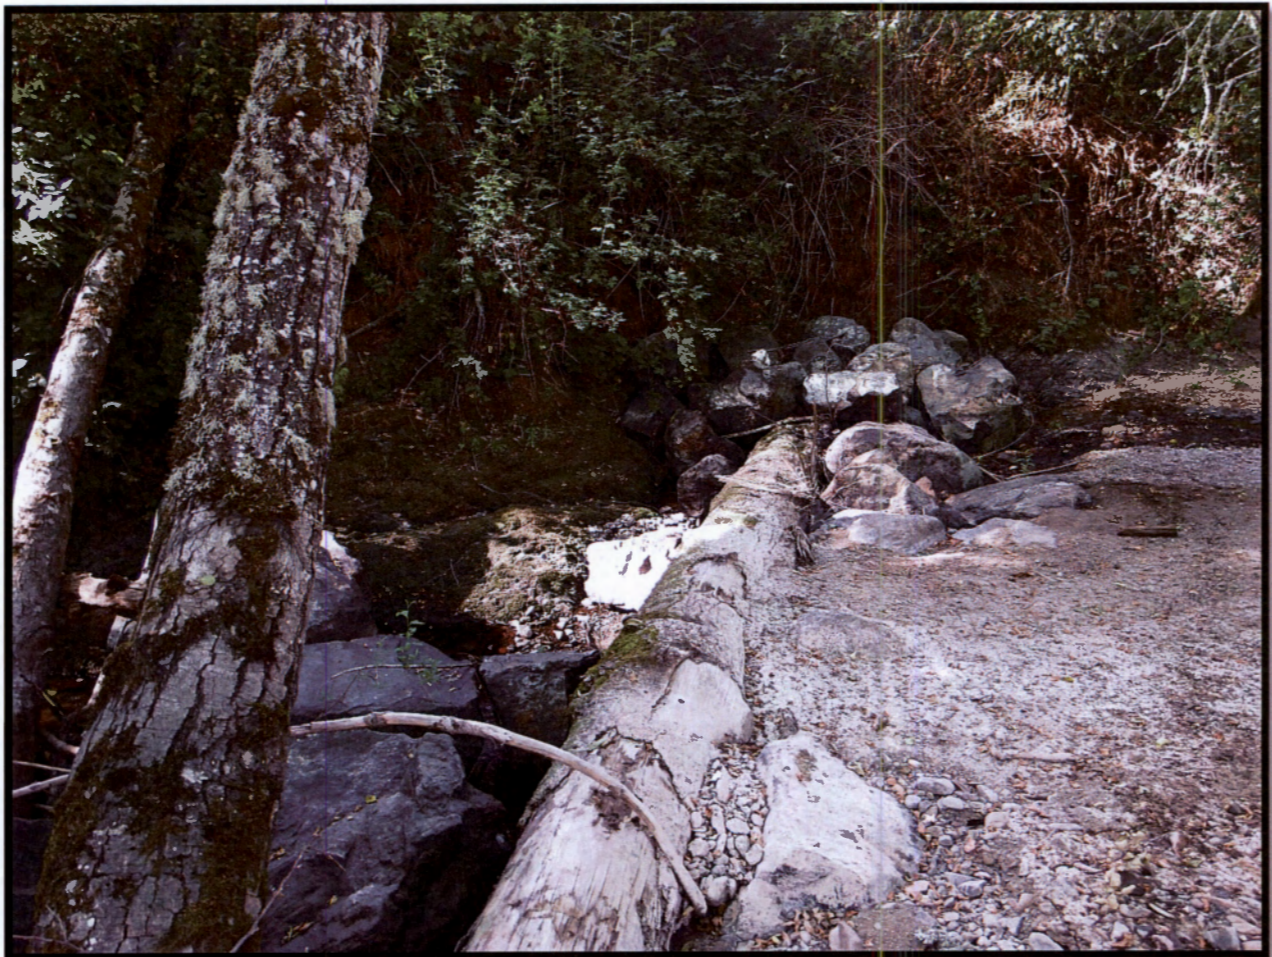
**Photo #10**

Days Creek Site 3

July 2015

Essentially unchanged from last year's photo #9 above.

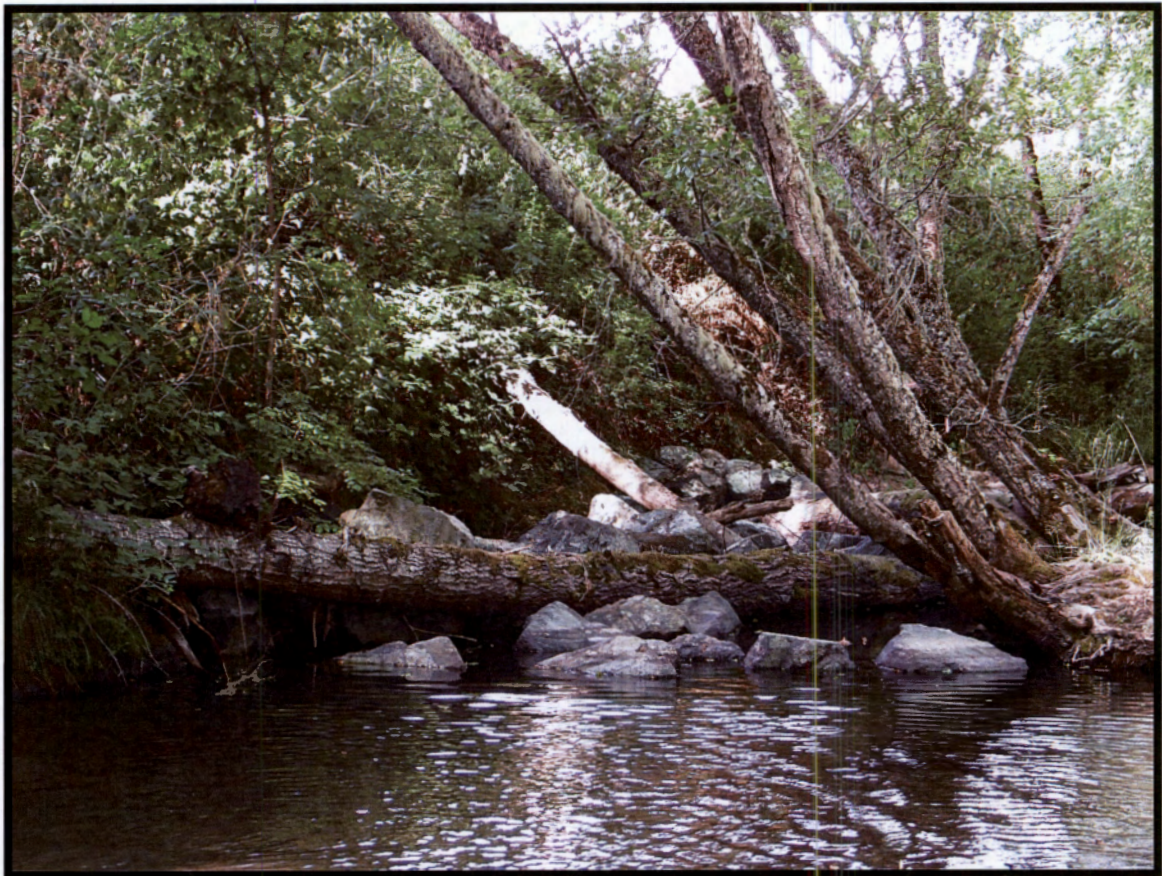
**Photo #15**  
Days Creek Site 3  
From downstream  
July 2015

A tree seen on the bank in Photo #14 has fallen into the creek adding more complexity to the structure.

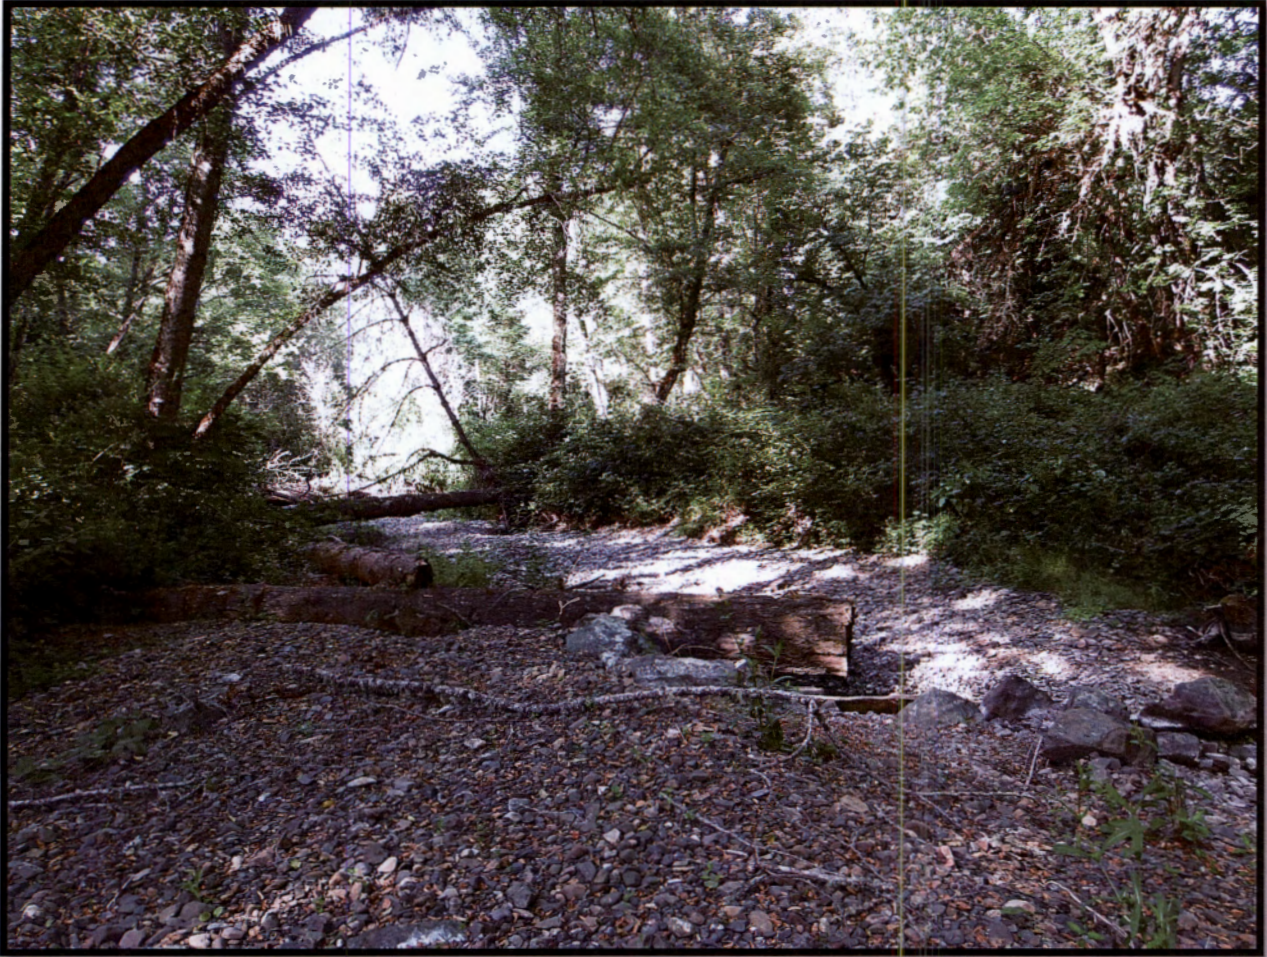
**Photo #21**

Upstream site on Days Creek, taken from first log in Photo #19 above. Quite a change occurred at this site. Two of the largest logs that were highest in the structure washed out and move downstream. The lowest log which was imbedded in gravel did not move. So much gravel has gathered downstream of this log, that the boulders on now totally covered in aggraded gravel.

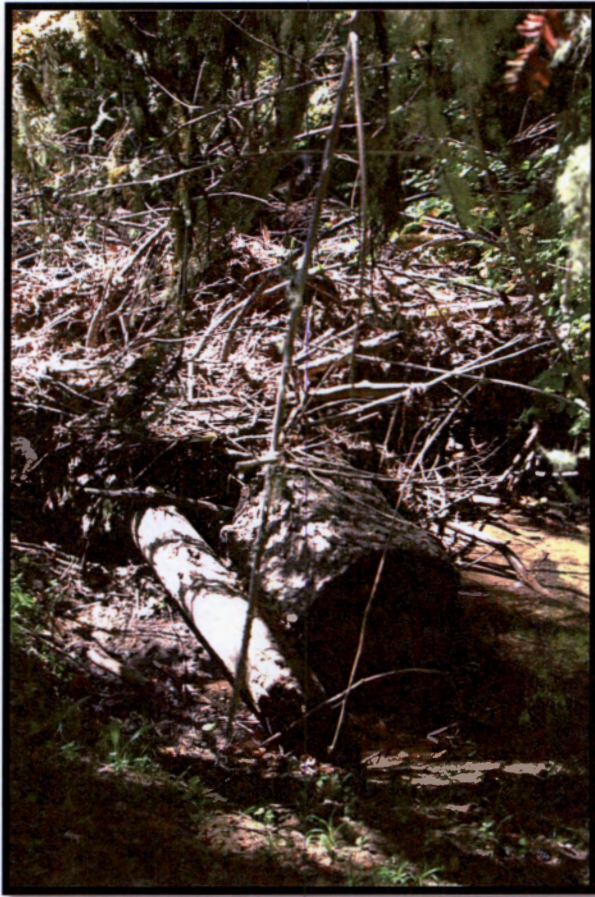
**Photo #26**

Same site on Fate Creek as in Photo #25 taken from upstream looking downstream. Huge amount of accumulation of woody debris.

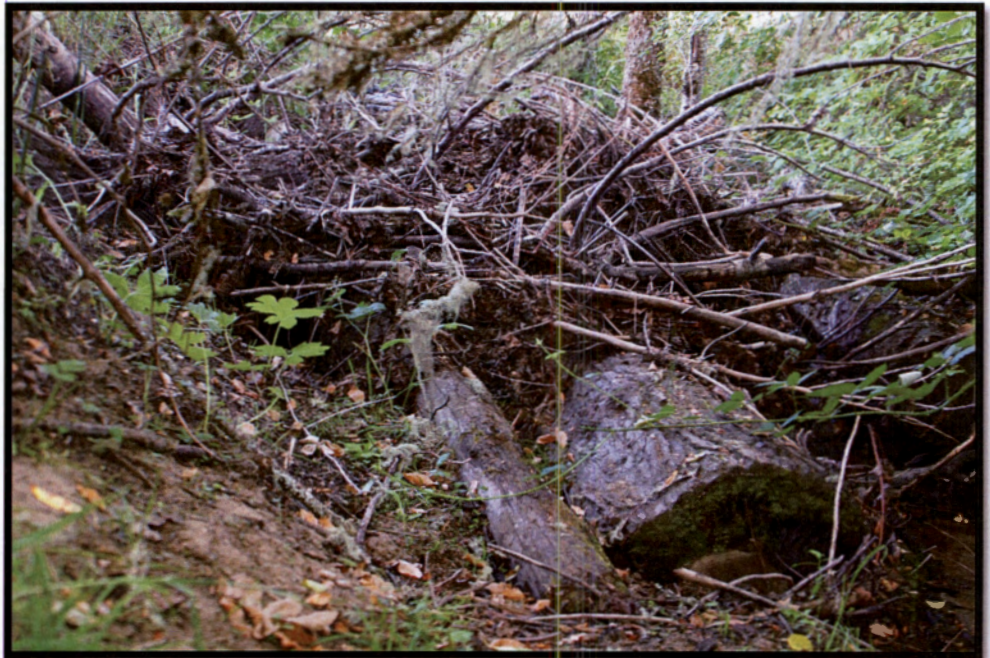
**Photo #27**

Same site July 2014  
The large log and smaller one to left are nearly embedded in substrate.

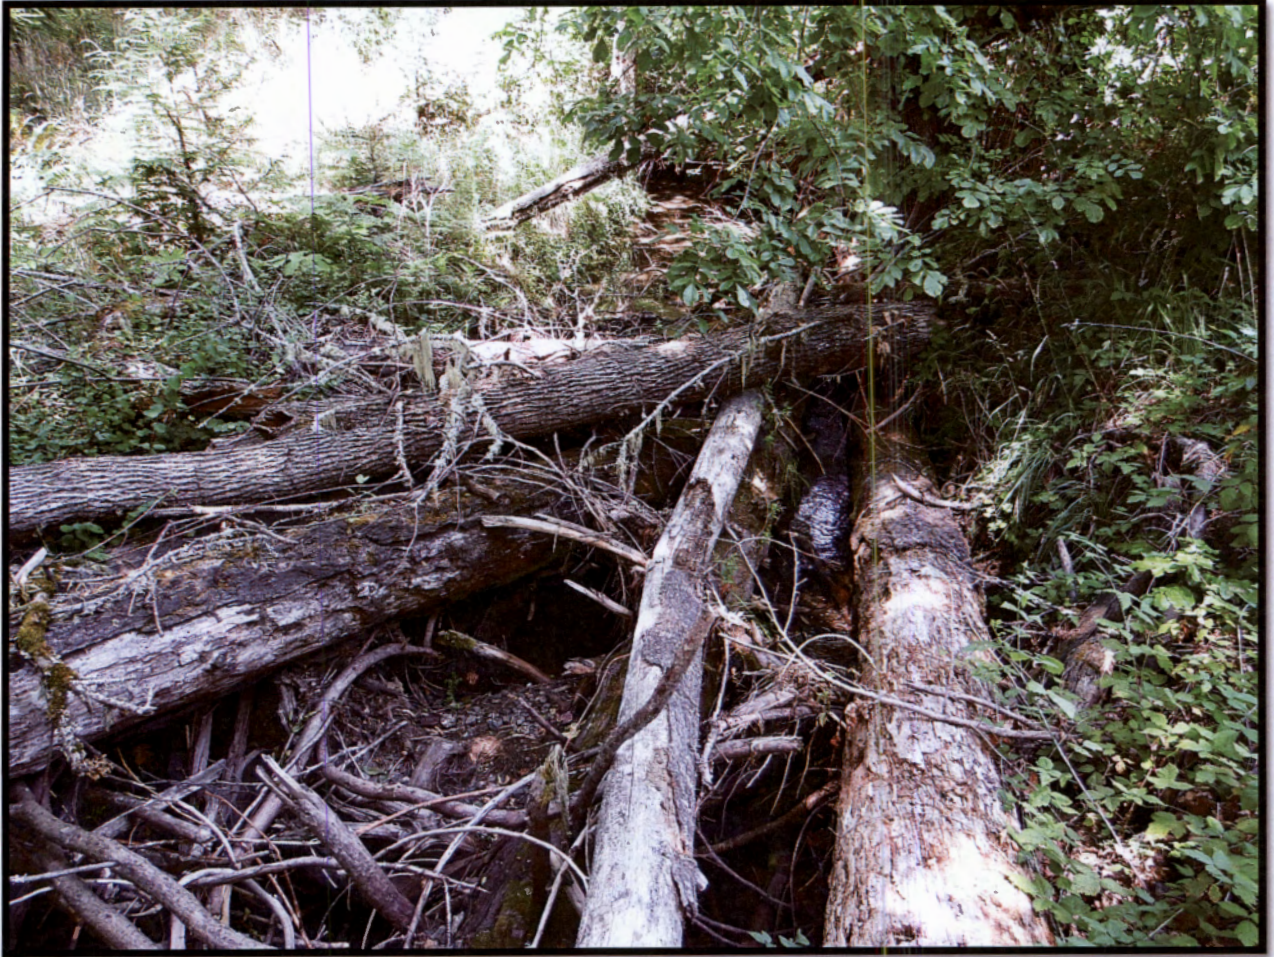
**Photo #28**

Same Mid-Fate Creek structure as in Photos #24 & 25  
looking upstream

July 2015

A riparian tree just upstream has falling into the creek adding further naturally placed structure to the creek.

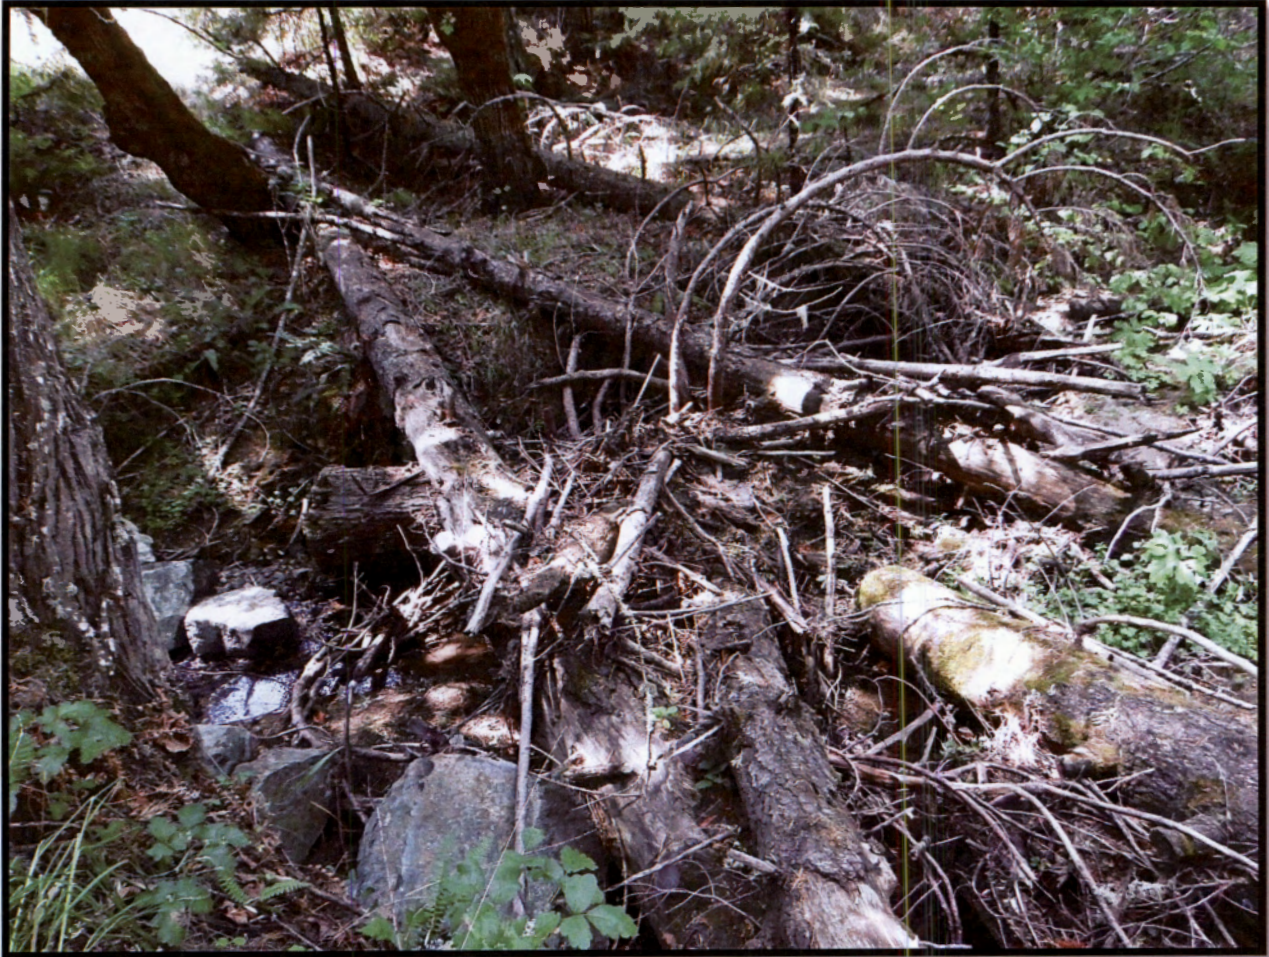
**Photo #29** July 2015

This structure is further up Fate Creek and had not been pictured before in our reports. It was created with boulders and some unlimbed trees. It has gathered so much more woody debris that you can barely see the creek producing some wonderful protected pools.
