Partnership for the Umpqua Rivers

**Rice Creek Effectiveness Monitoring Project
Progress Report
Presented to the Hydrologists' Breakfast
10/1/2020**

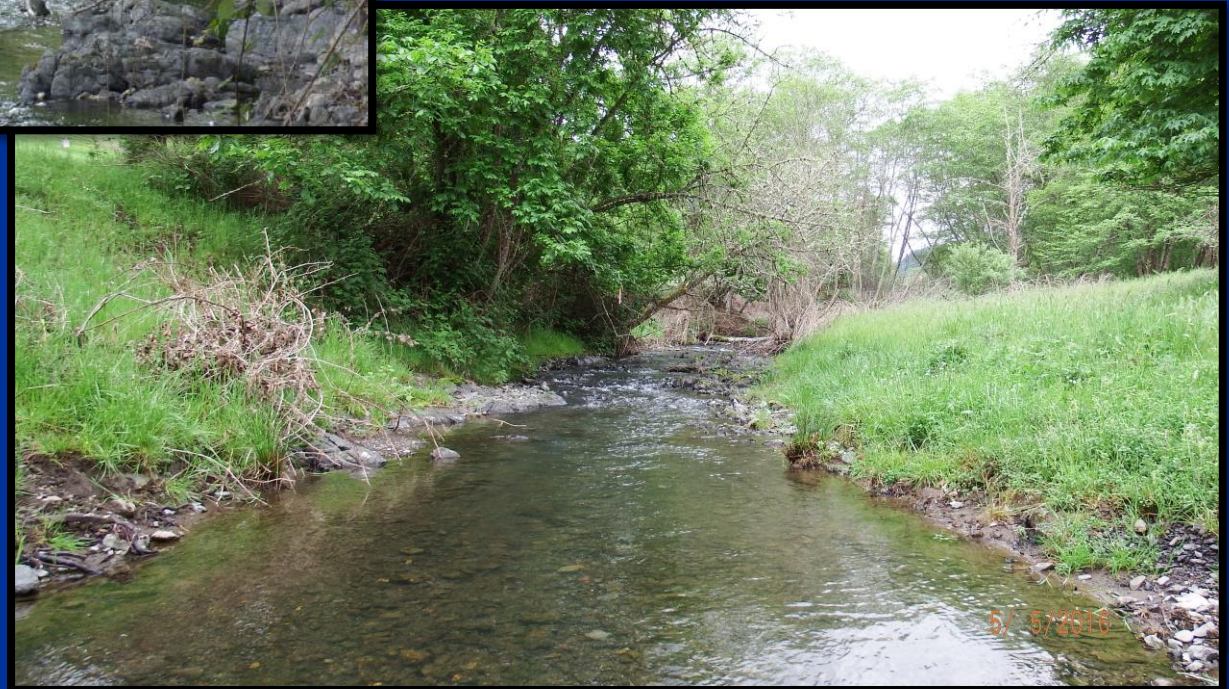
Rice Creek Stream Bank, Photo Point and Instream Structure Locations

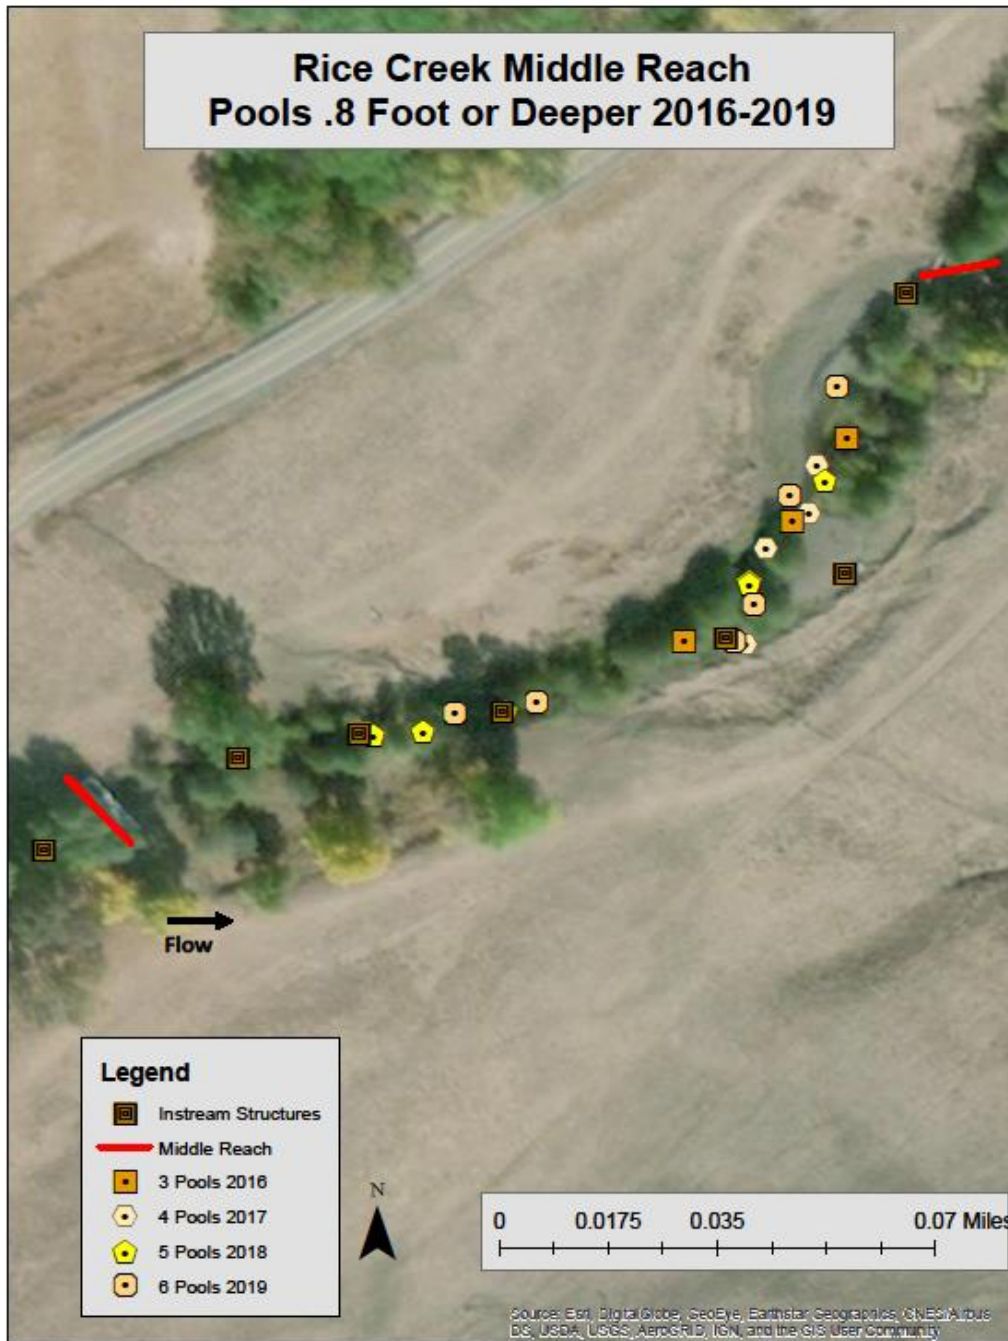
Rice Creek Middle Reach Pools .8 Foot or Deeper 2016-2019

- In mid-September each year the areas of disconnected channel have been mapped.
- In conjunction with this survey the number, location and size of pools that are greater or equal to .8' are mapped. This information has been collected 4 years, two pre structure and two post structure placement.

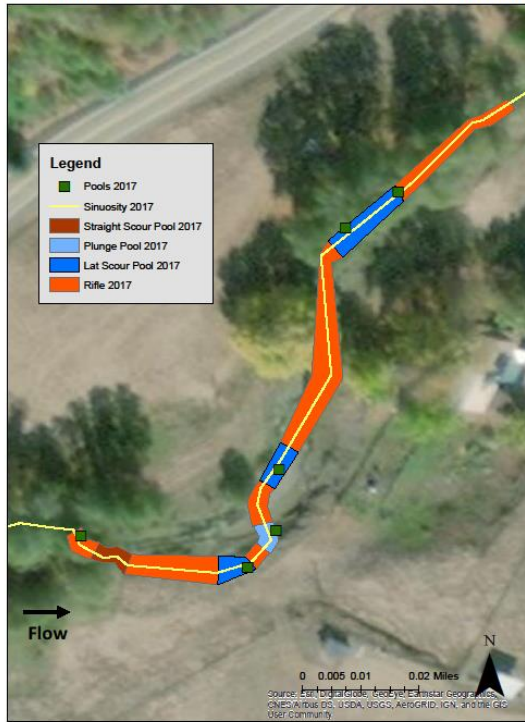
2017 Lower Reach Habitat Units, Sinuosity and Pools

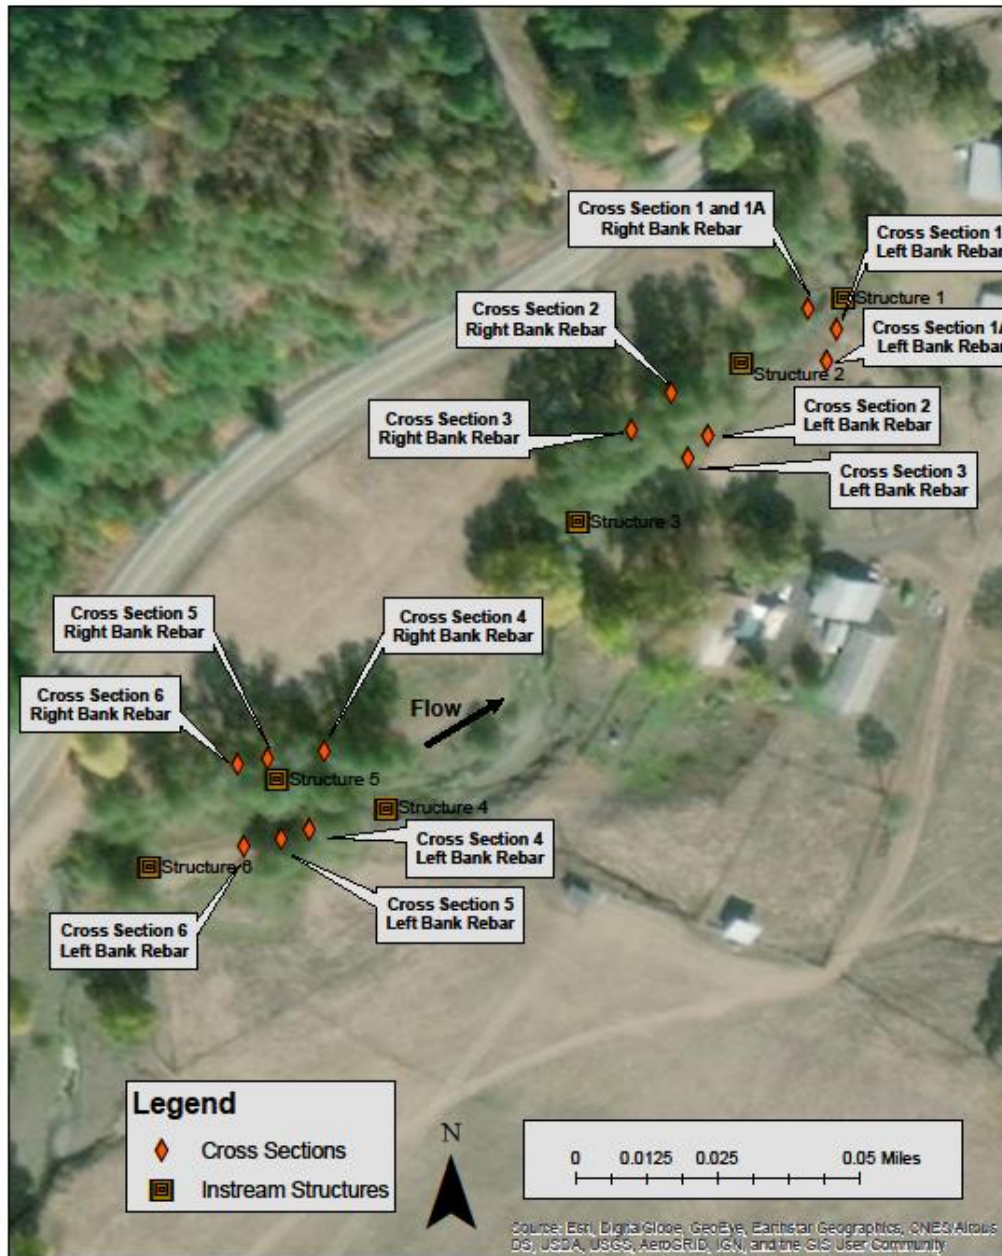
Rice Creek Lower Reach Cross Section Locations

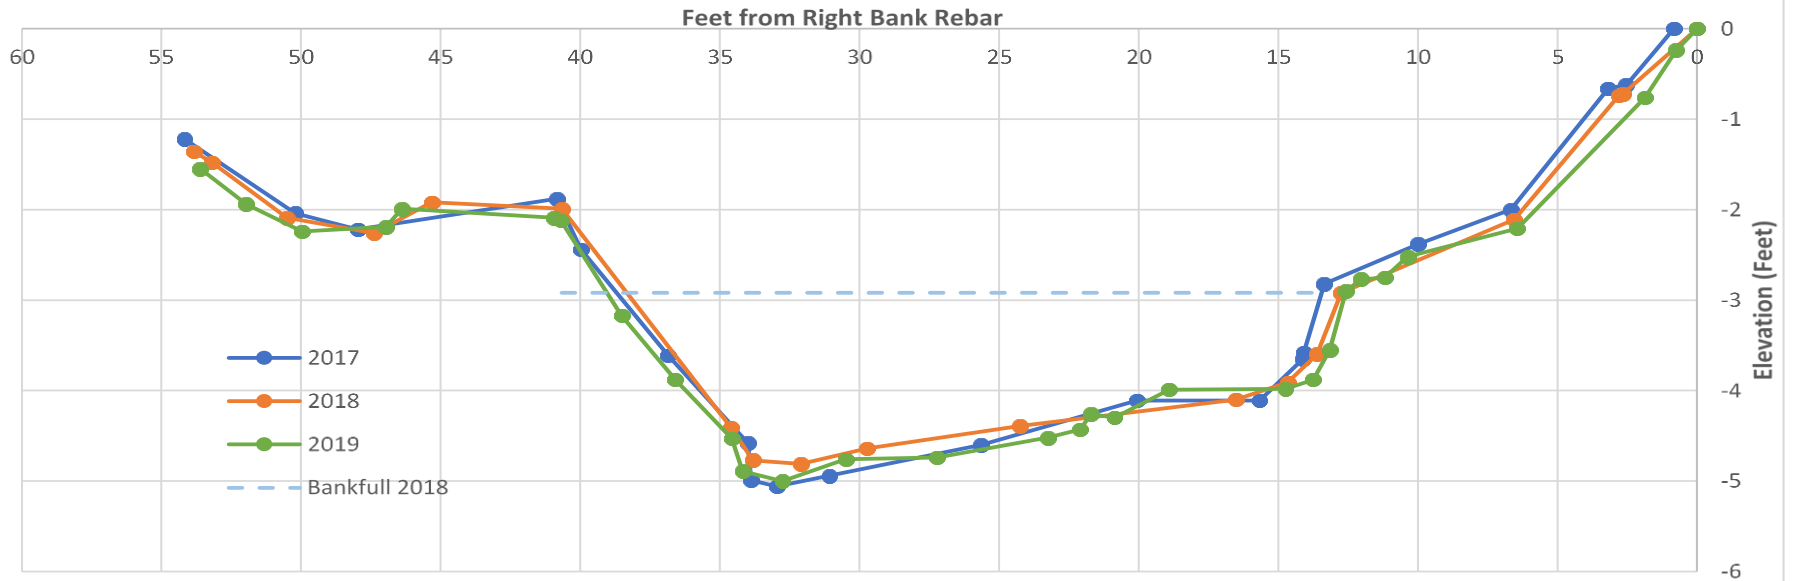
**Rice Creek Cross Section 3 - 1 Year Pre (2017), 1 Year Post (2018) and 2 Years Post (2019)
40 Feet Upstream of Structure 2**

- Cross sections were established in 2017 placing three cross sections at each structure were setup, two structures per reach for a total of 18 cross sections around 6 structures. During low flows after each year's winter rain events the cross sections are repeated to profile changes in the stream. Cross sections have been conducted 3 time one pre and two post.
- Pebble counts are collected each year in conjunction with the cross-section profile

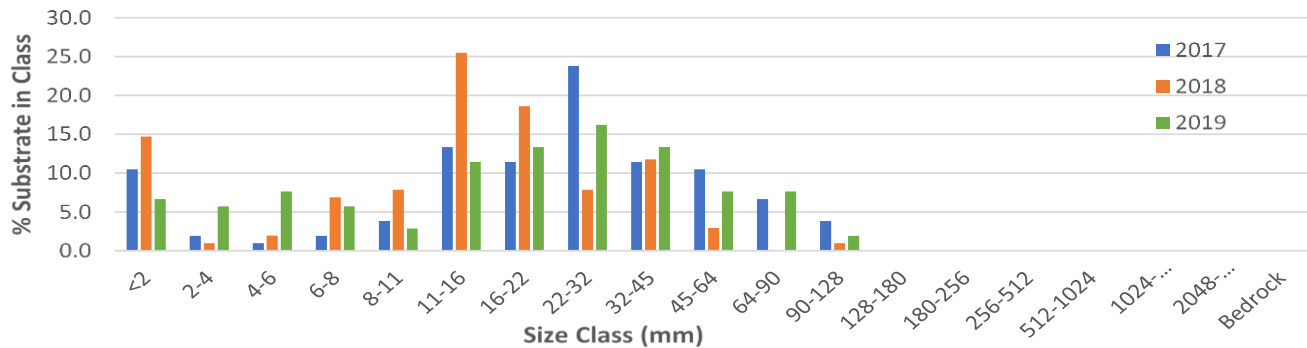
**Pebble Counts Cross Section 3 – 1 Year Pre (2017), 1 Year Post (2018) and 2 Years Post (2019)
40 Feet Upstream of Structure 2**

2017 D50 = 22-32 mm

2018 D50 = 11-16 mm

2019 D50 = 16-22 mm

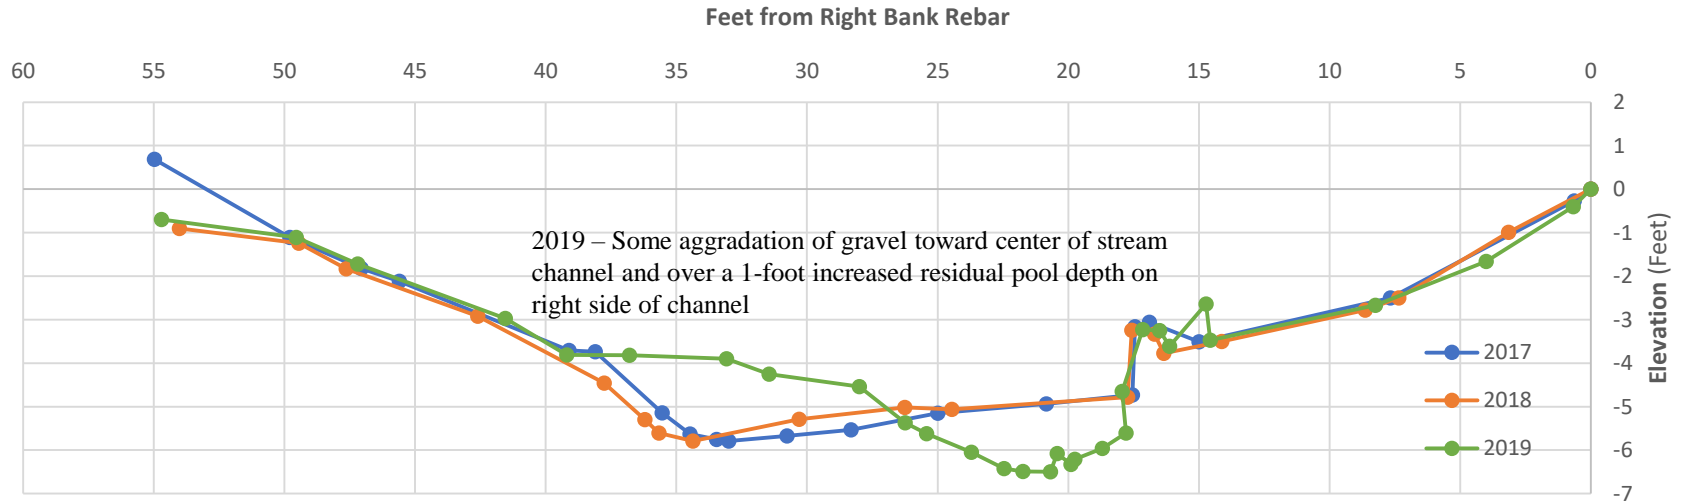
**Rice Creek Cross Section 10 - 1 Year Pre (2017), 1 Year Post (2018) and 2 Years Post (2019)
15 Feet Downstream of Structure 11**

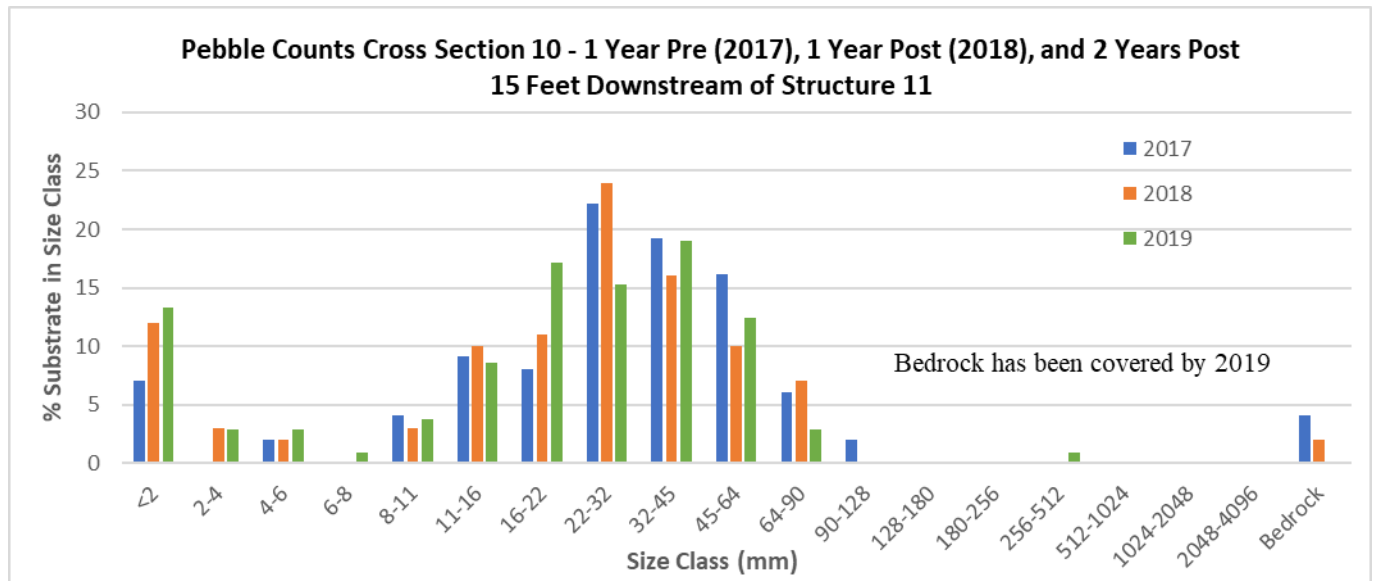
Pebble Counts
 2017 D50 = 22-32 mm
 2018 D50 = 22-32 mm
 2019 D50 = 8-11 mm

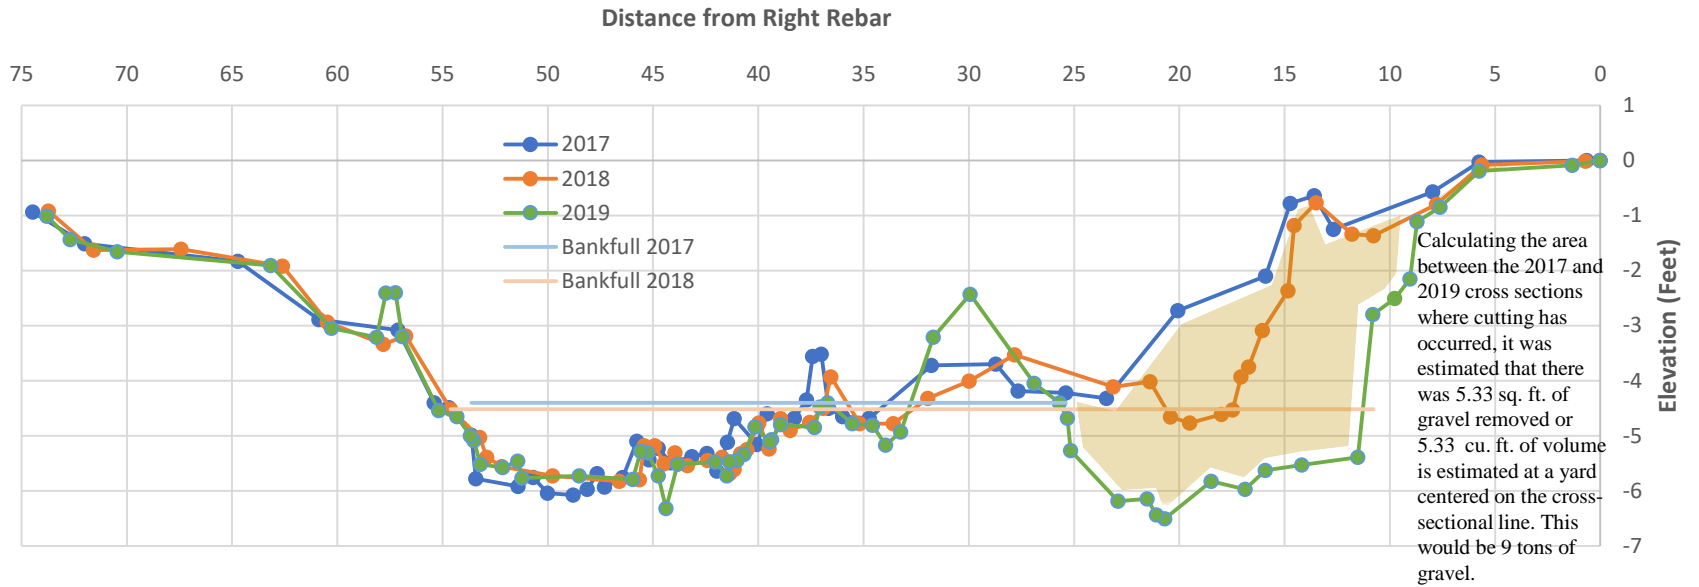
Rice Creek Cross Section 13 - 15 Feet Downstream of Structure Year Zero (2017), Year One (2018) and Year Two (2019)

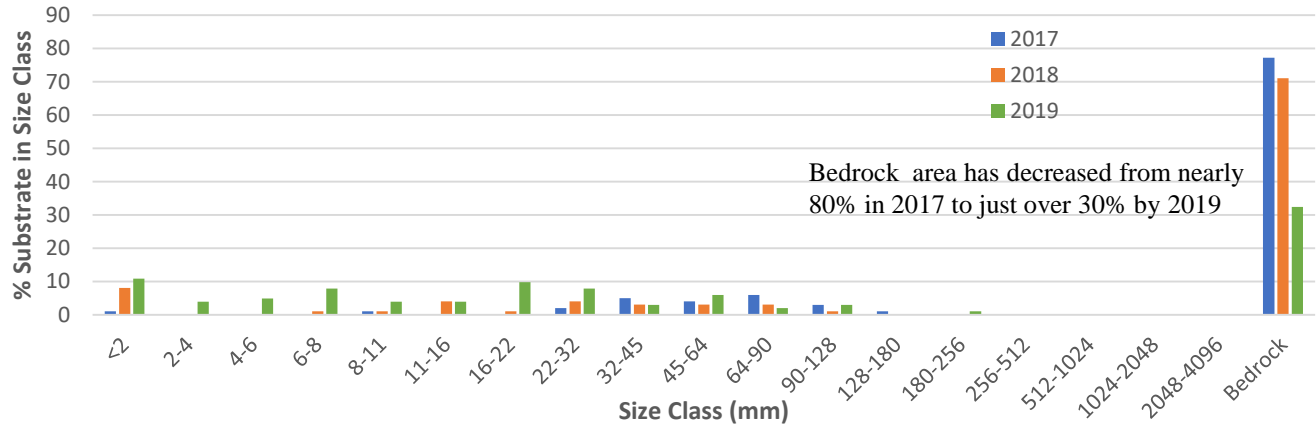
Pebble Counts Cross Section 13 - 1 Year Pre (2017), 1 Year Post (2018) and 2 Years Post (2019) 15 Feet Downstream of Structure 18

Pebble Counts
 2017 D50 = Bedrock
 2018 D50 = Bedrock
 2019 D50 = 16-22 mm

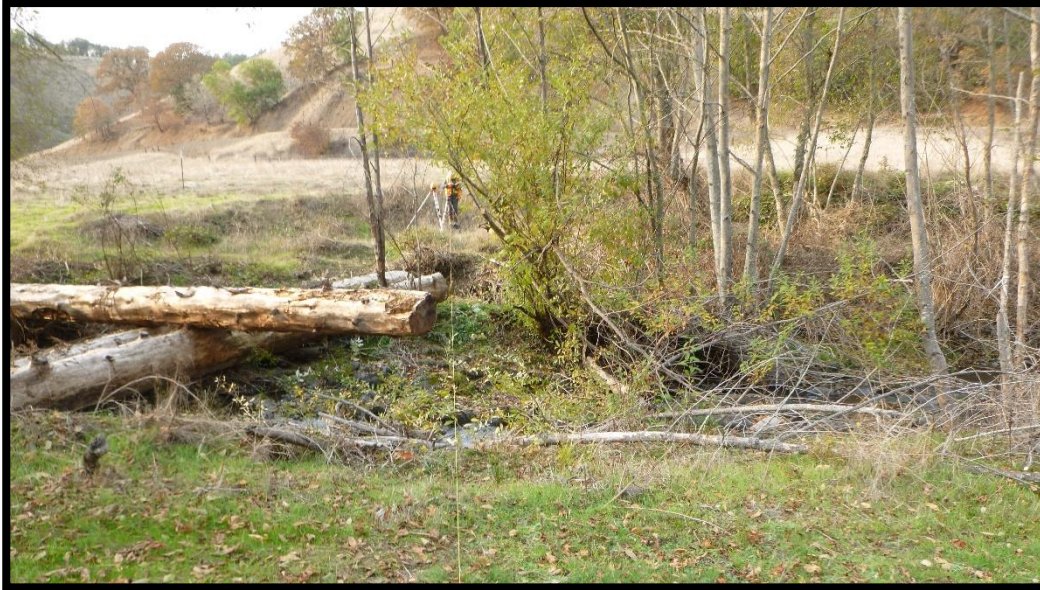
11/13/2018

In this photo you can just see the erosion starting off the end of the logs pointing to the right bank.

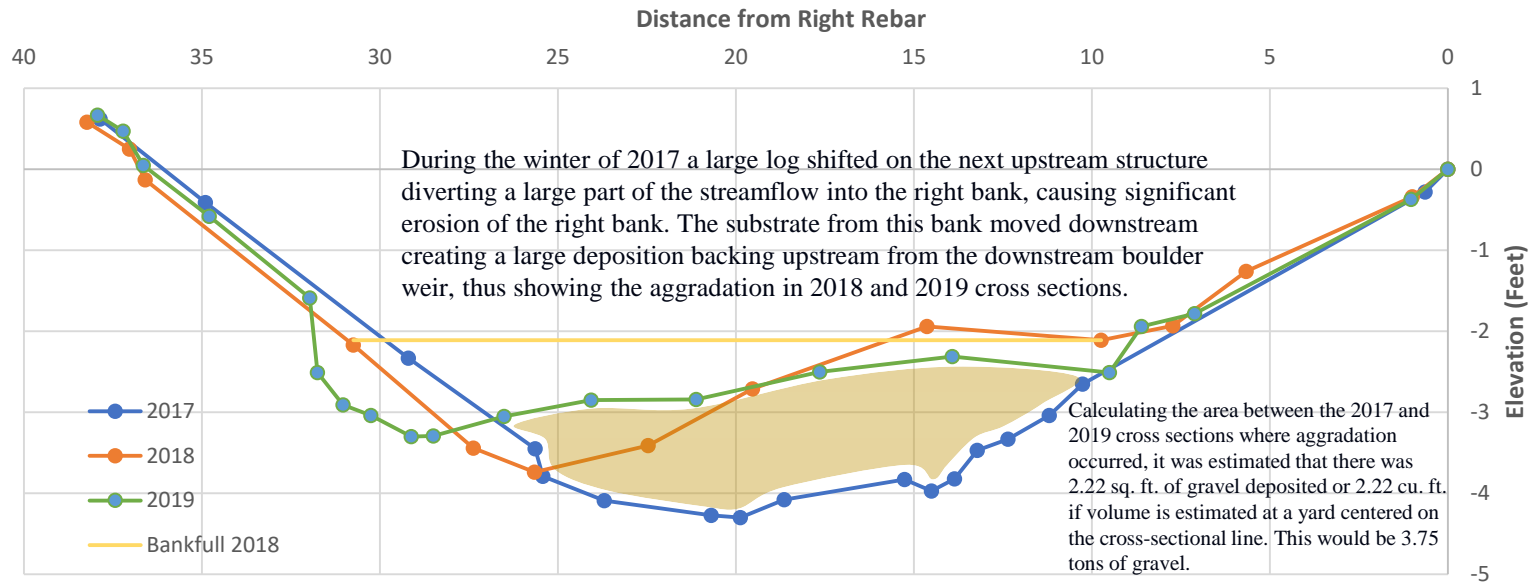
Rice Creek Cross Section 17 - 15 Feet Upstream of Structure 20 1 Year Pre (2017), 1 Year Post (2018) and 2 Years Post (2019)

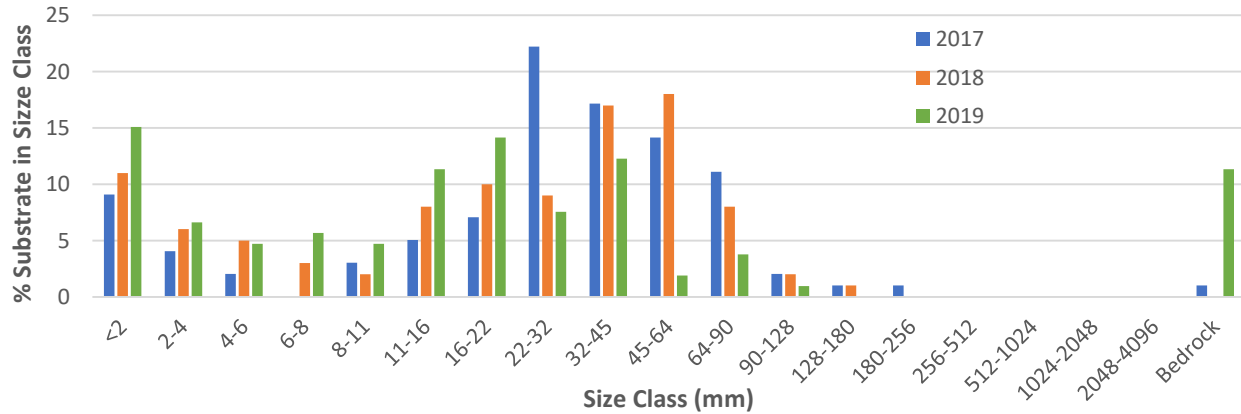
Pebble Counts Cross Section 17 - 1 Year Pre (2017), 1 Year Post (2018) and 2 Years Post (2019)

Pebble Counts
 2017 D50 = 22-32 mm
 2018 D50 = 22-32 mm
 2019 D50 = 16-22 mm

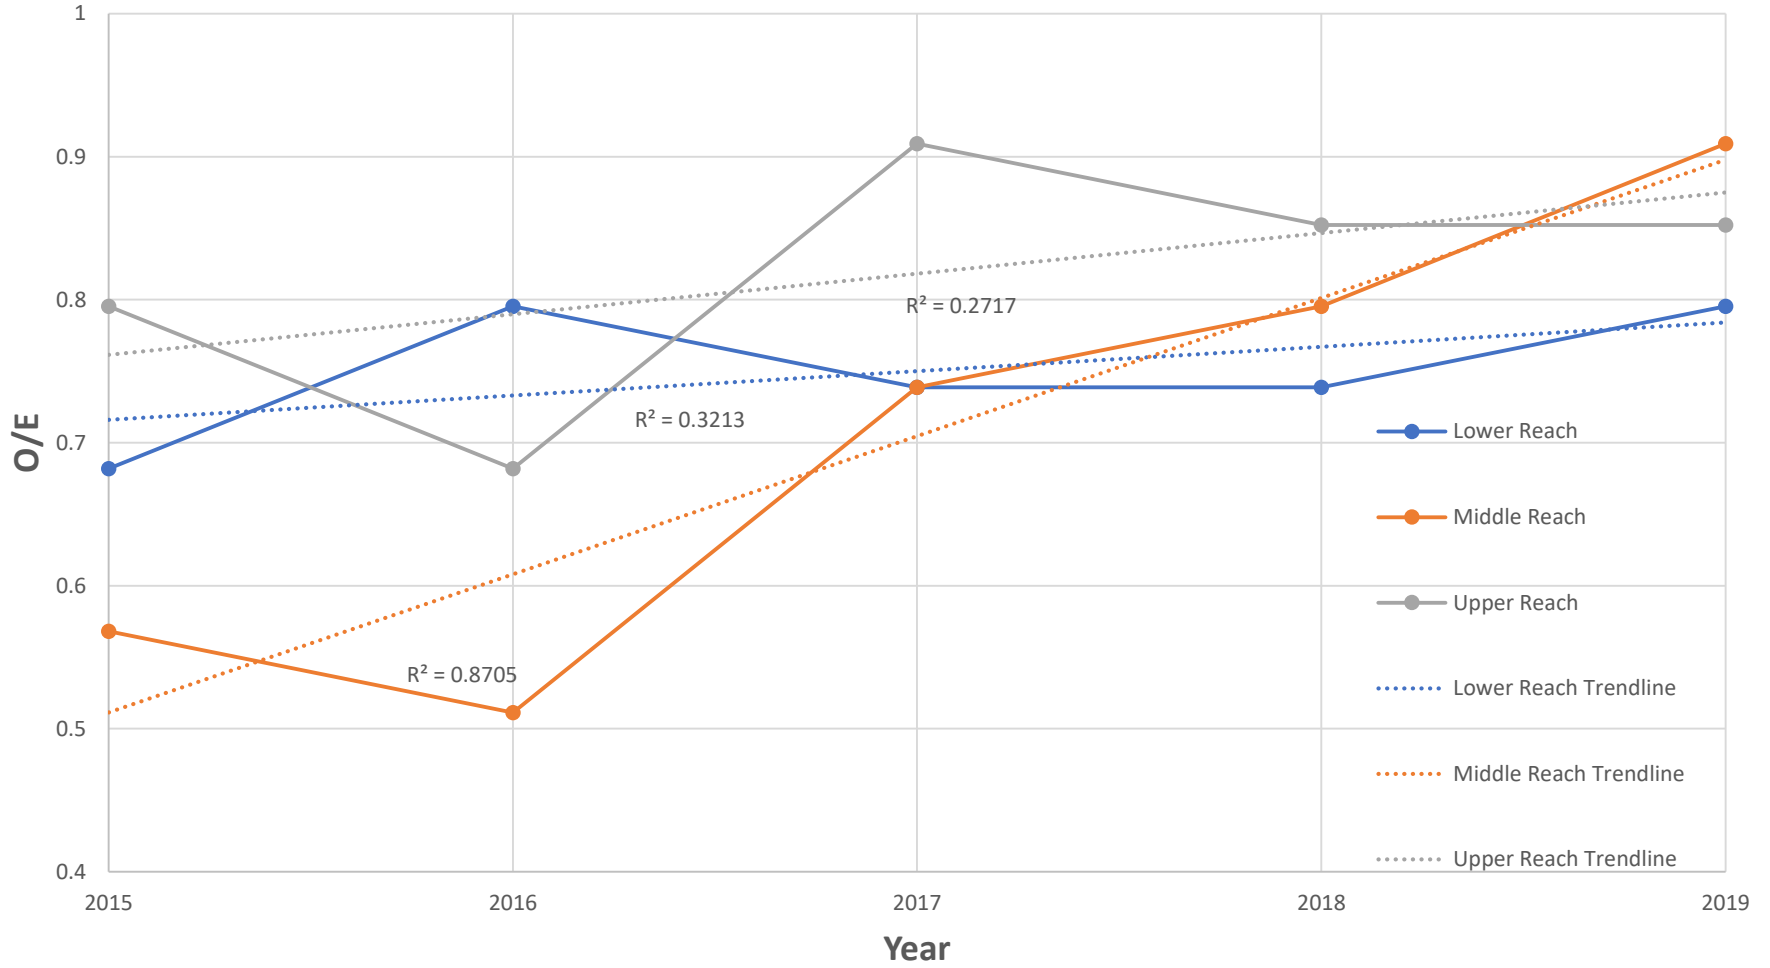
O/E Results for Rice Creek Study 2015-2019				
Year	Lower Reach	Middle Reach	Upper Reach	
2015	0.6818			Three years pre
2016	0.7954			Two years pre
2017	0.7386			Pre on year of structure placement
2018	0.7386			First year post structure placements
2018	0.6818			Duplicate 2018, Difference O/E Duplicates = 0.0566817
2019	0.7954			Second year post structure placements
2015		0.5682		Three years pre
2016		0.5114		Two years pre
2017		0.7386		Pre on year of structure placement
2018		0.7954		First year post structure placements
2019		0.9091		Second year post structure placements
2015			0.7954	Three years pre
2016			0.6818	Two years pre
2017			0.9091	Pre on year of structure placement
2018			0.8523	First year post structure placements
2019			0.8523	Second year post structure placements

Macroinvertebrate Observed/Expected (O/E)

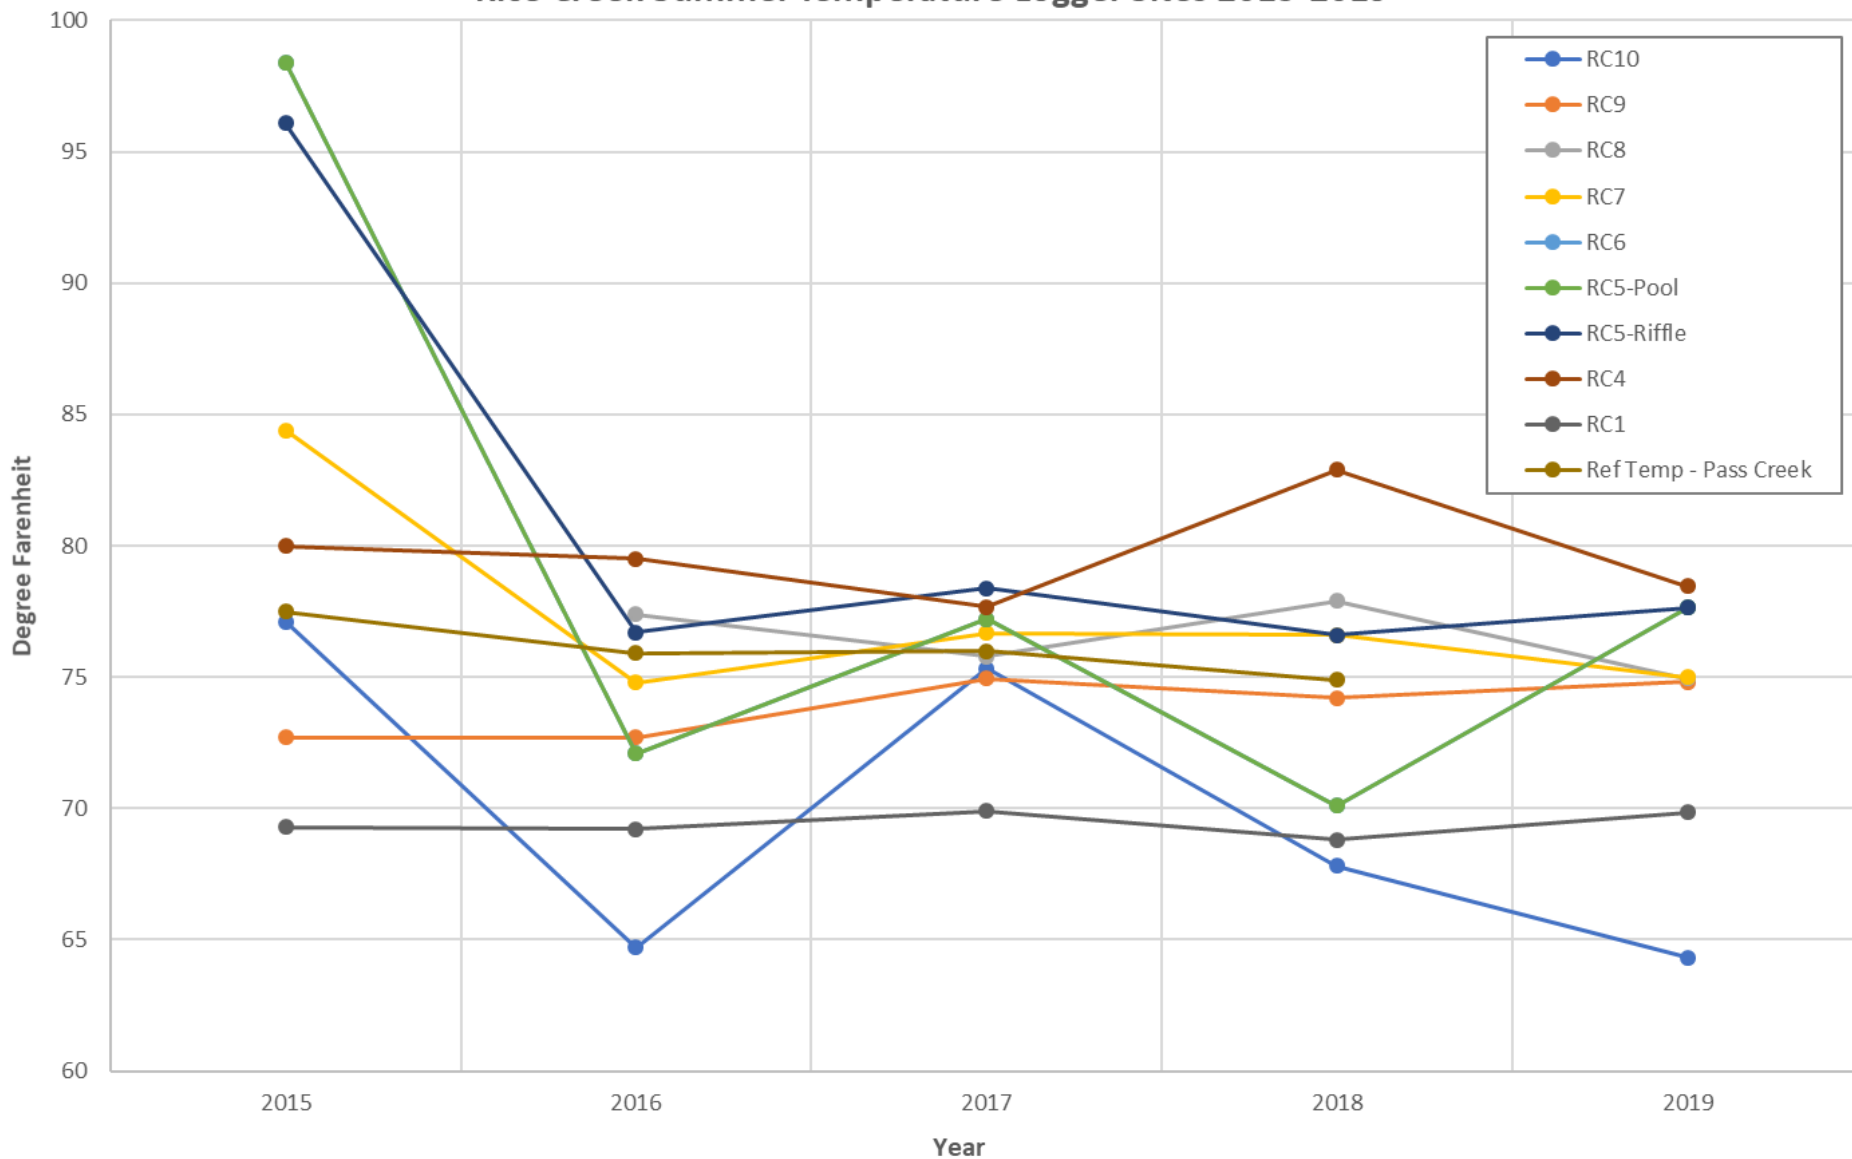
7-Day Average Maximum Temperature Rice Creek Summer Temperature Logger Sites 2015-2019

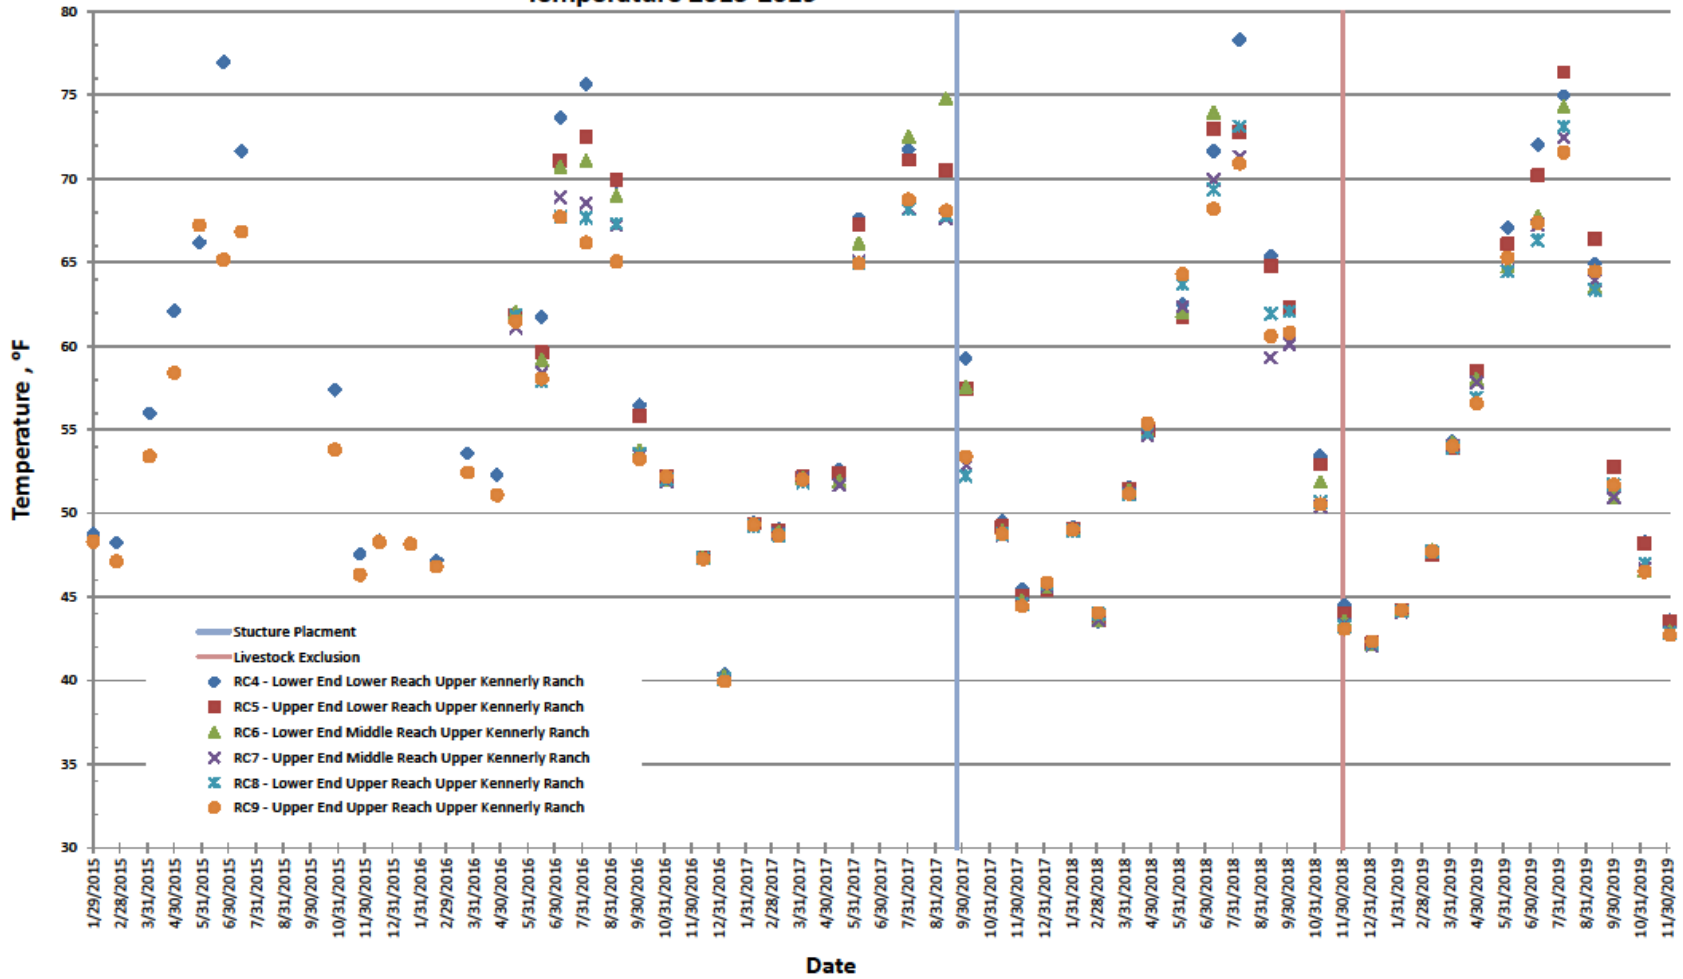
Rice Creek Effectiveness Monitoring Temperature 2015-2019

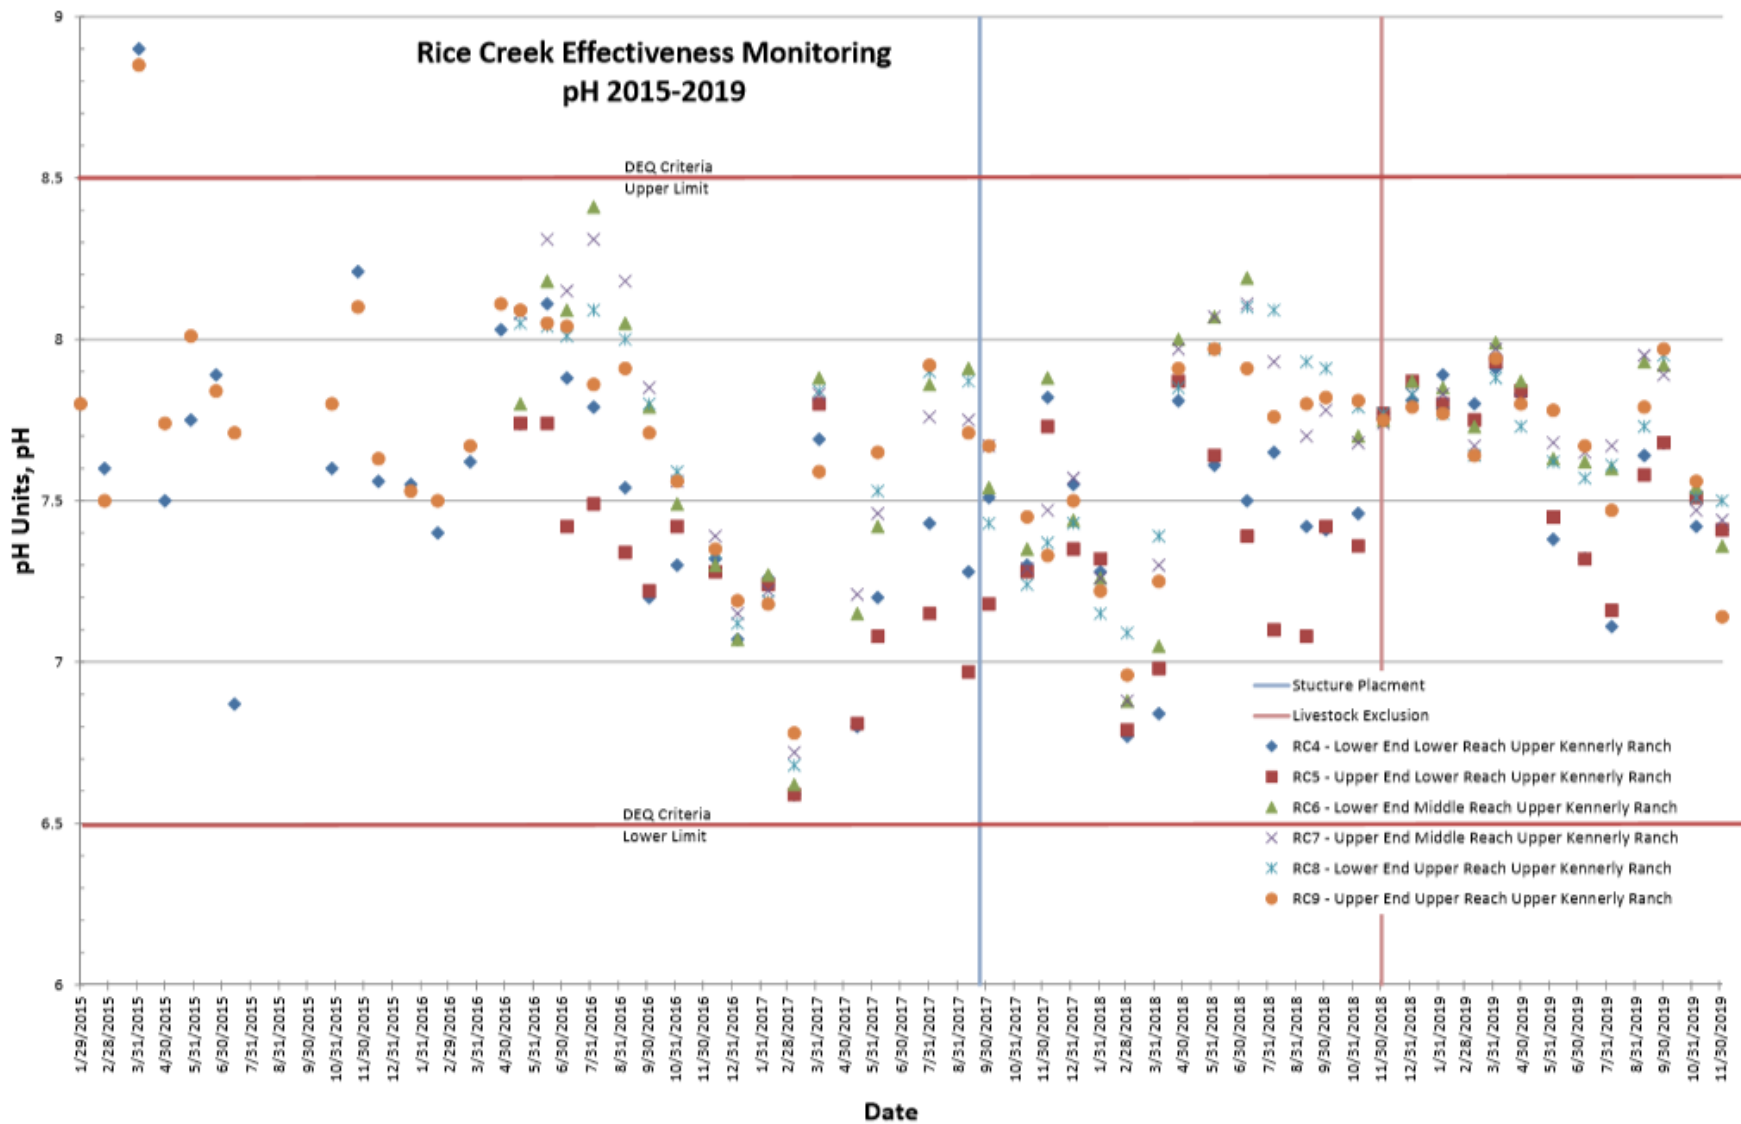
Rice Creek Effectiveness Monitoring pH 2015-2019

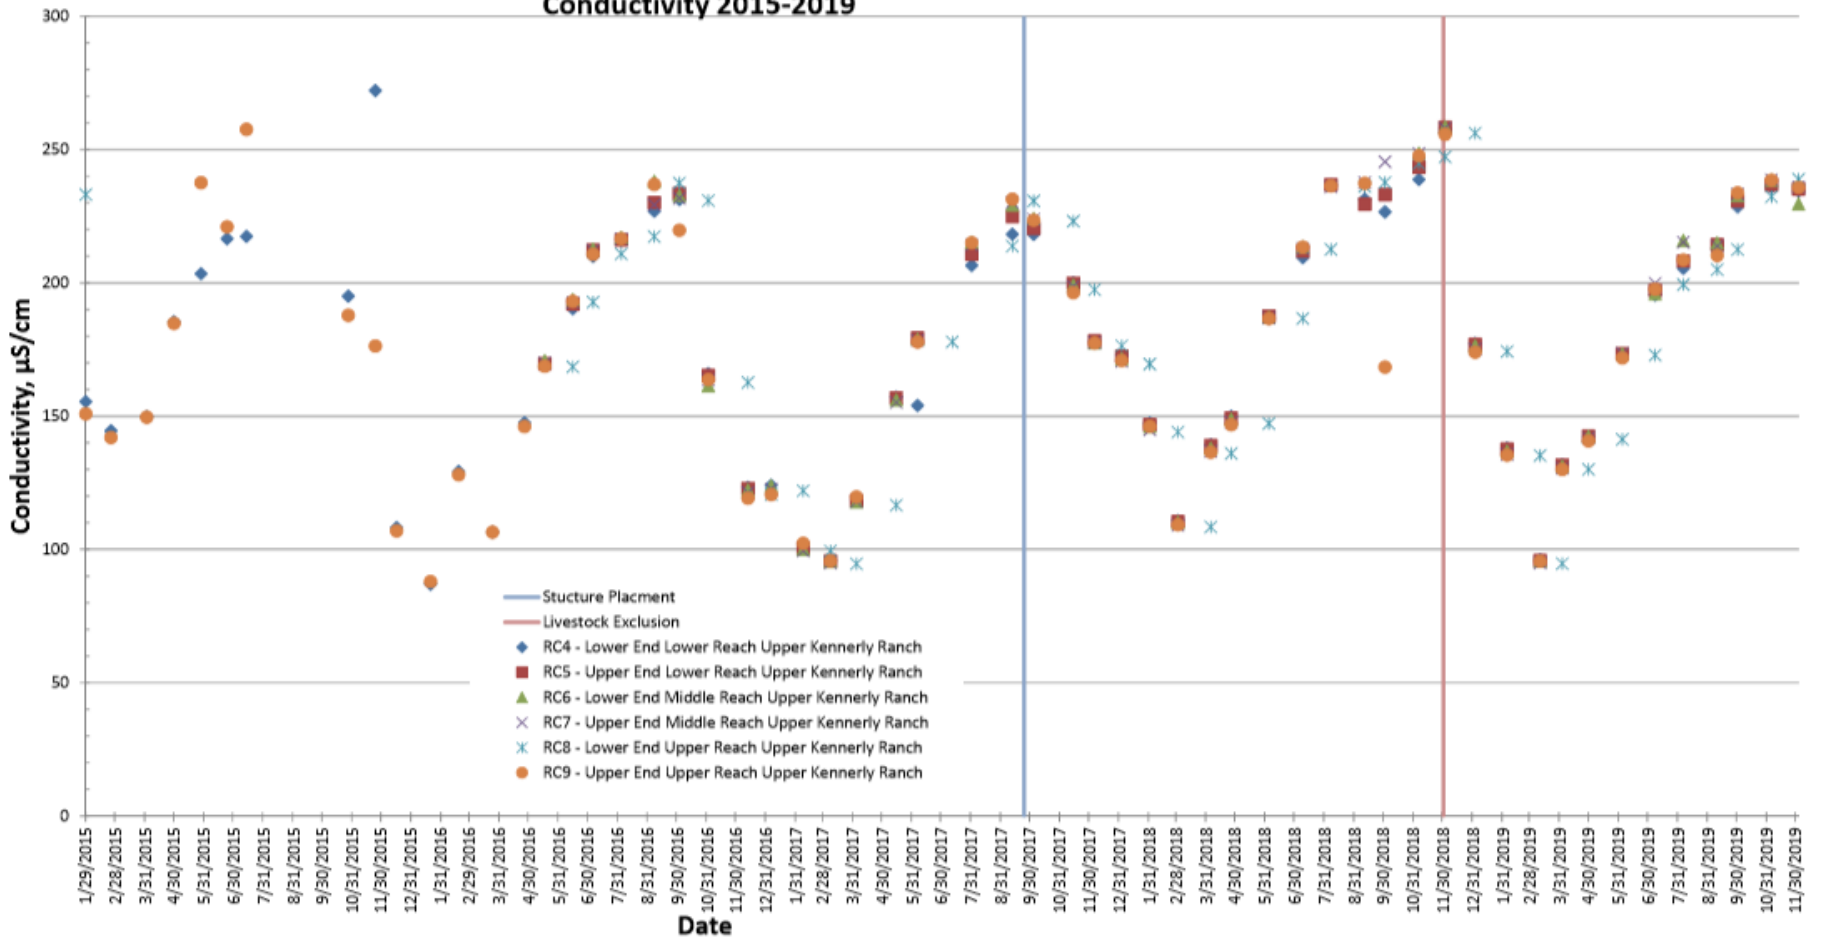
Rice Creek Effectiveness Monitoring Conductivity 2015-2019

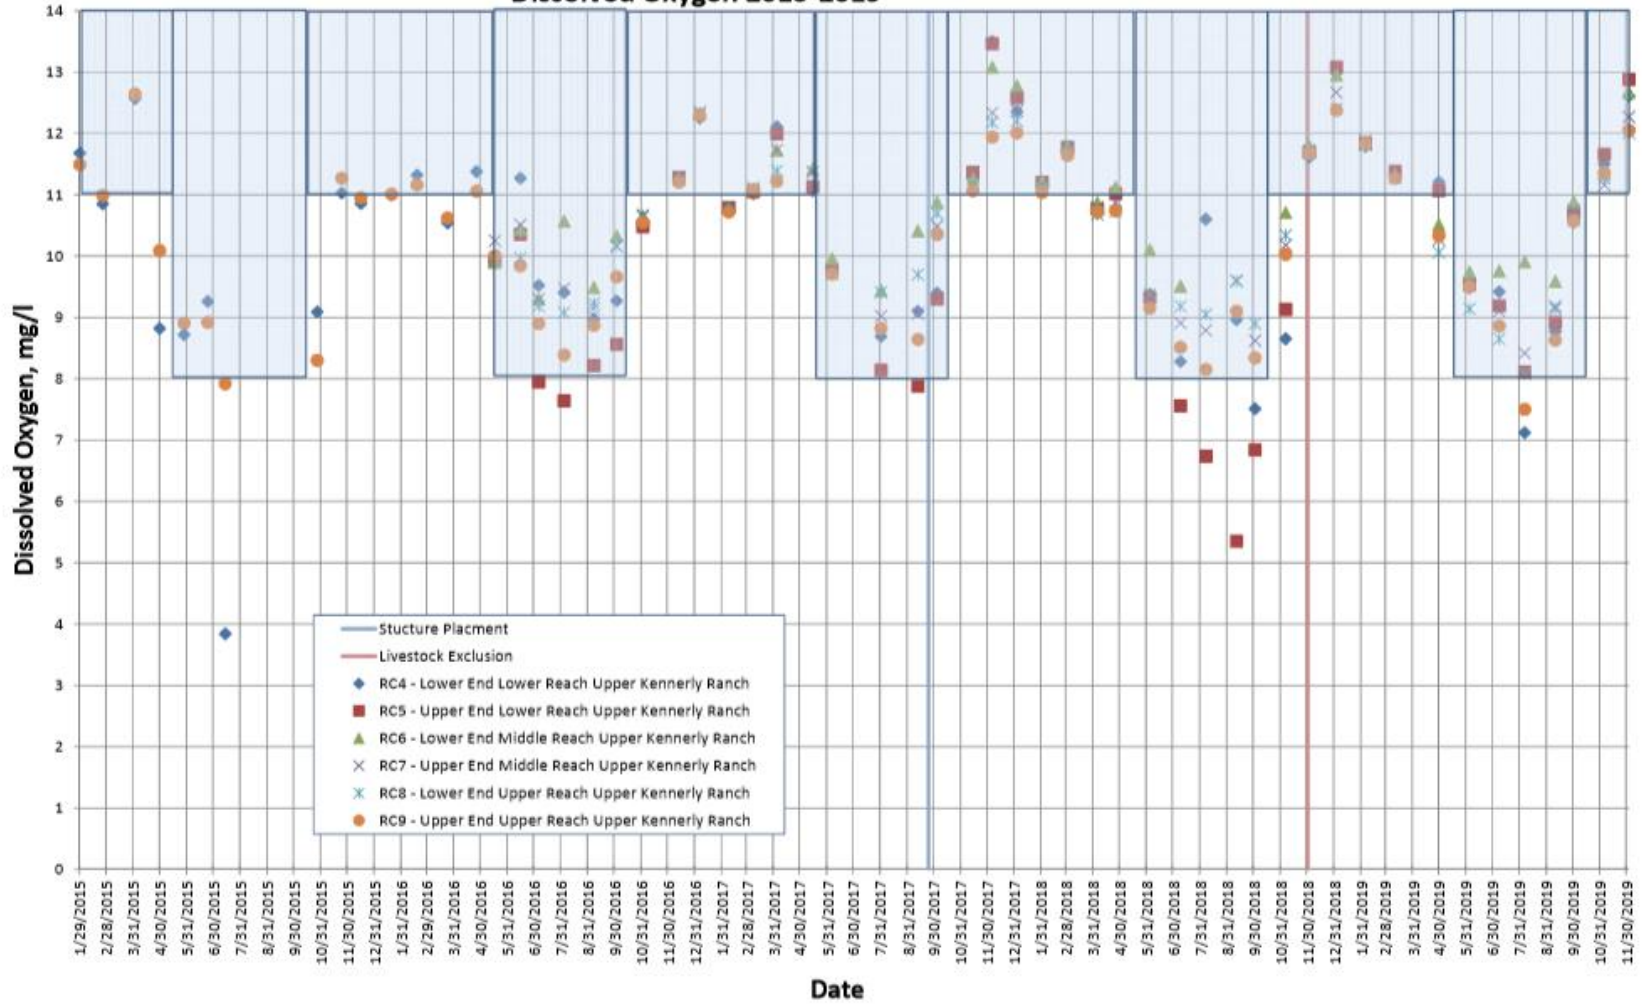
Rice Creek Effectiveness Monitoring Dissolved Oxygen 2015-2019
