Partnership for the Umpqua Rivers

**Rice Creek Effectiveness Monitoring Project
Progress Report
Presented to the Hydrologists' Breakfast
10/1/2020**

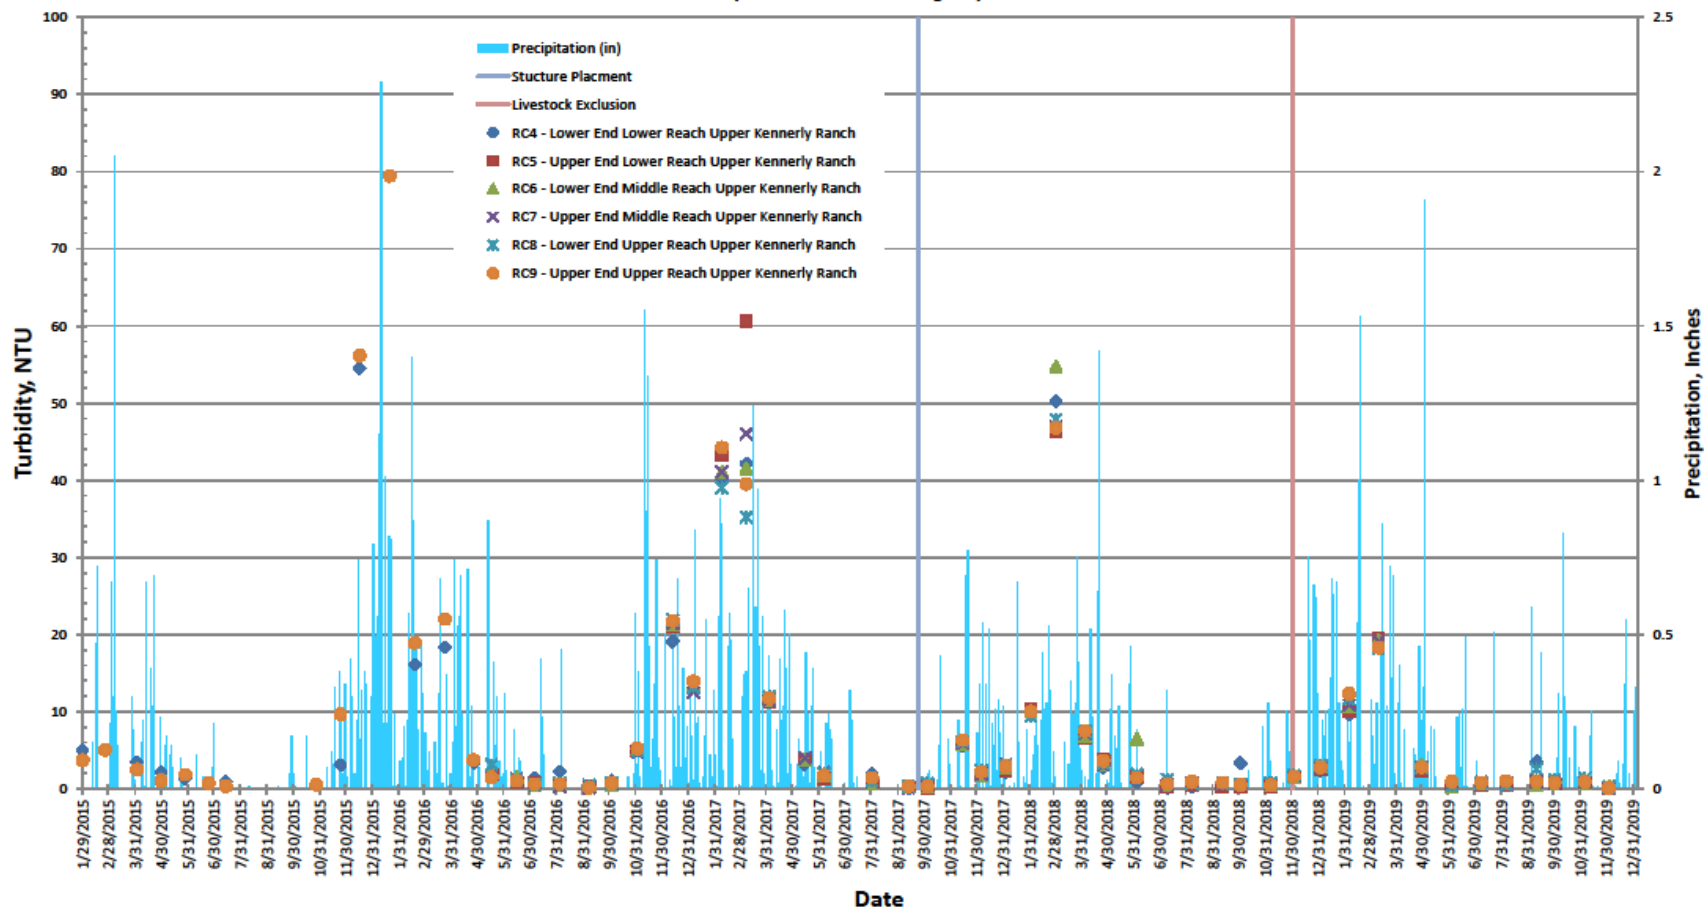
Rice Creek Effectiveness Monitoring Turbidity & Daily Precipitation 2015-2019

**Precipitaion from Roseburg Airport

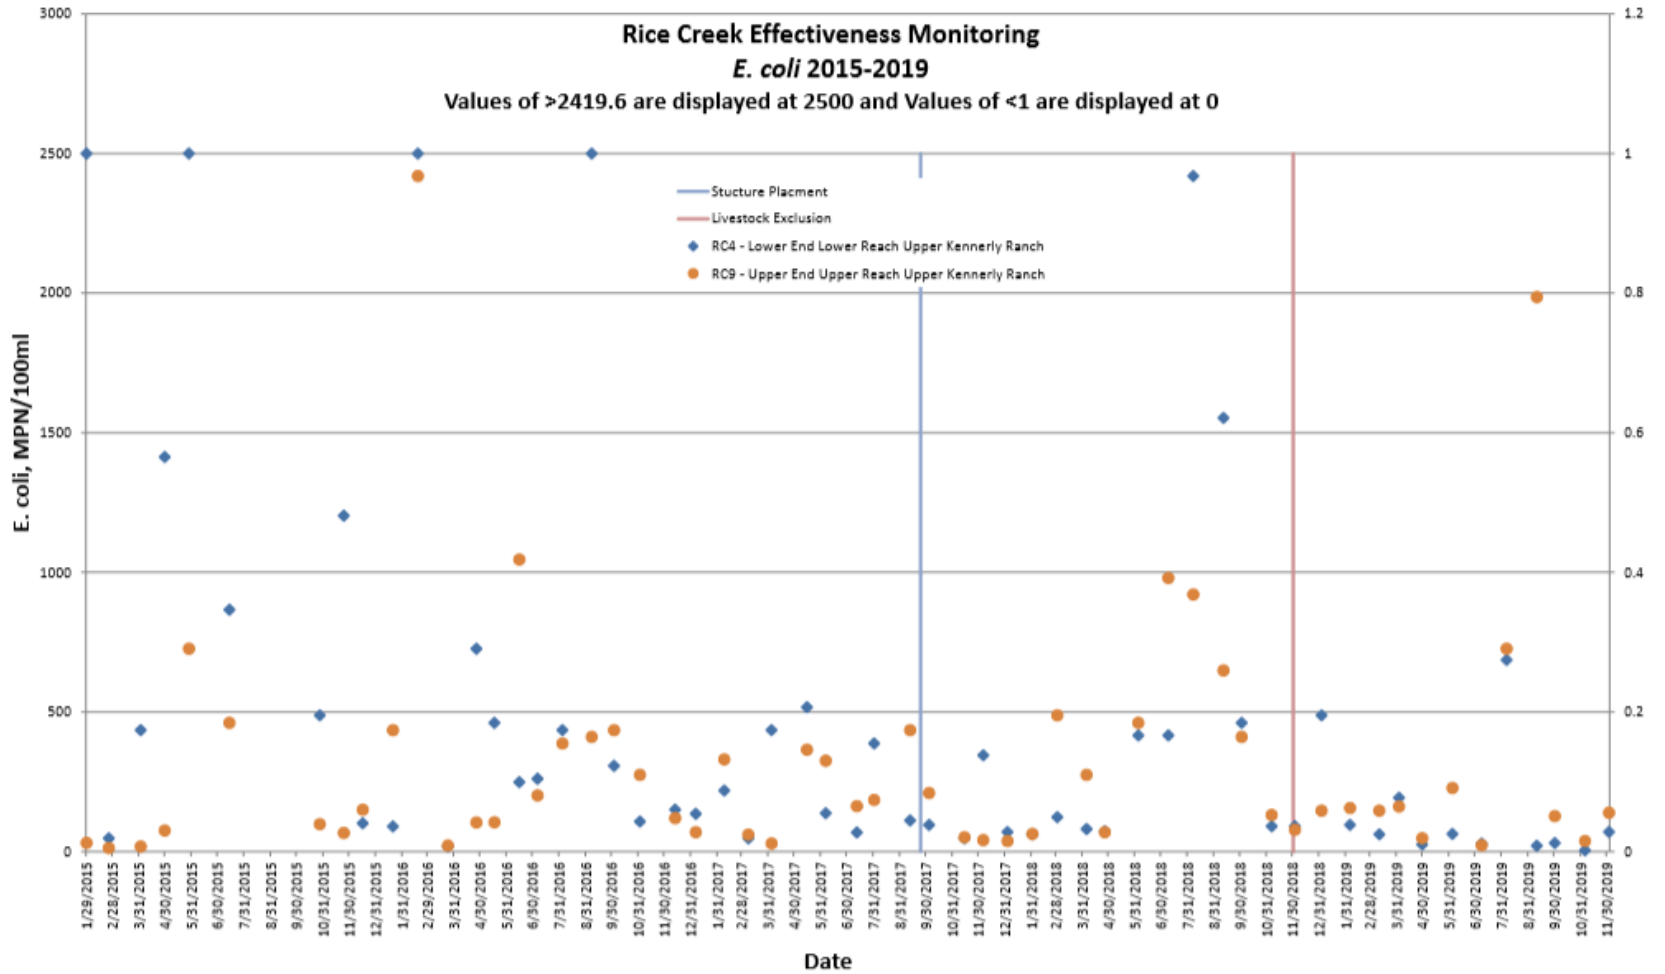
E. coli 2015-2019

Values of >2419.6 are displayed at 2500 and Values of <1 are displayed at 0

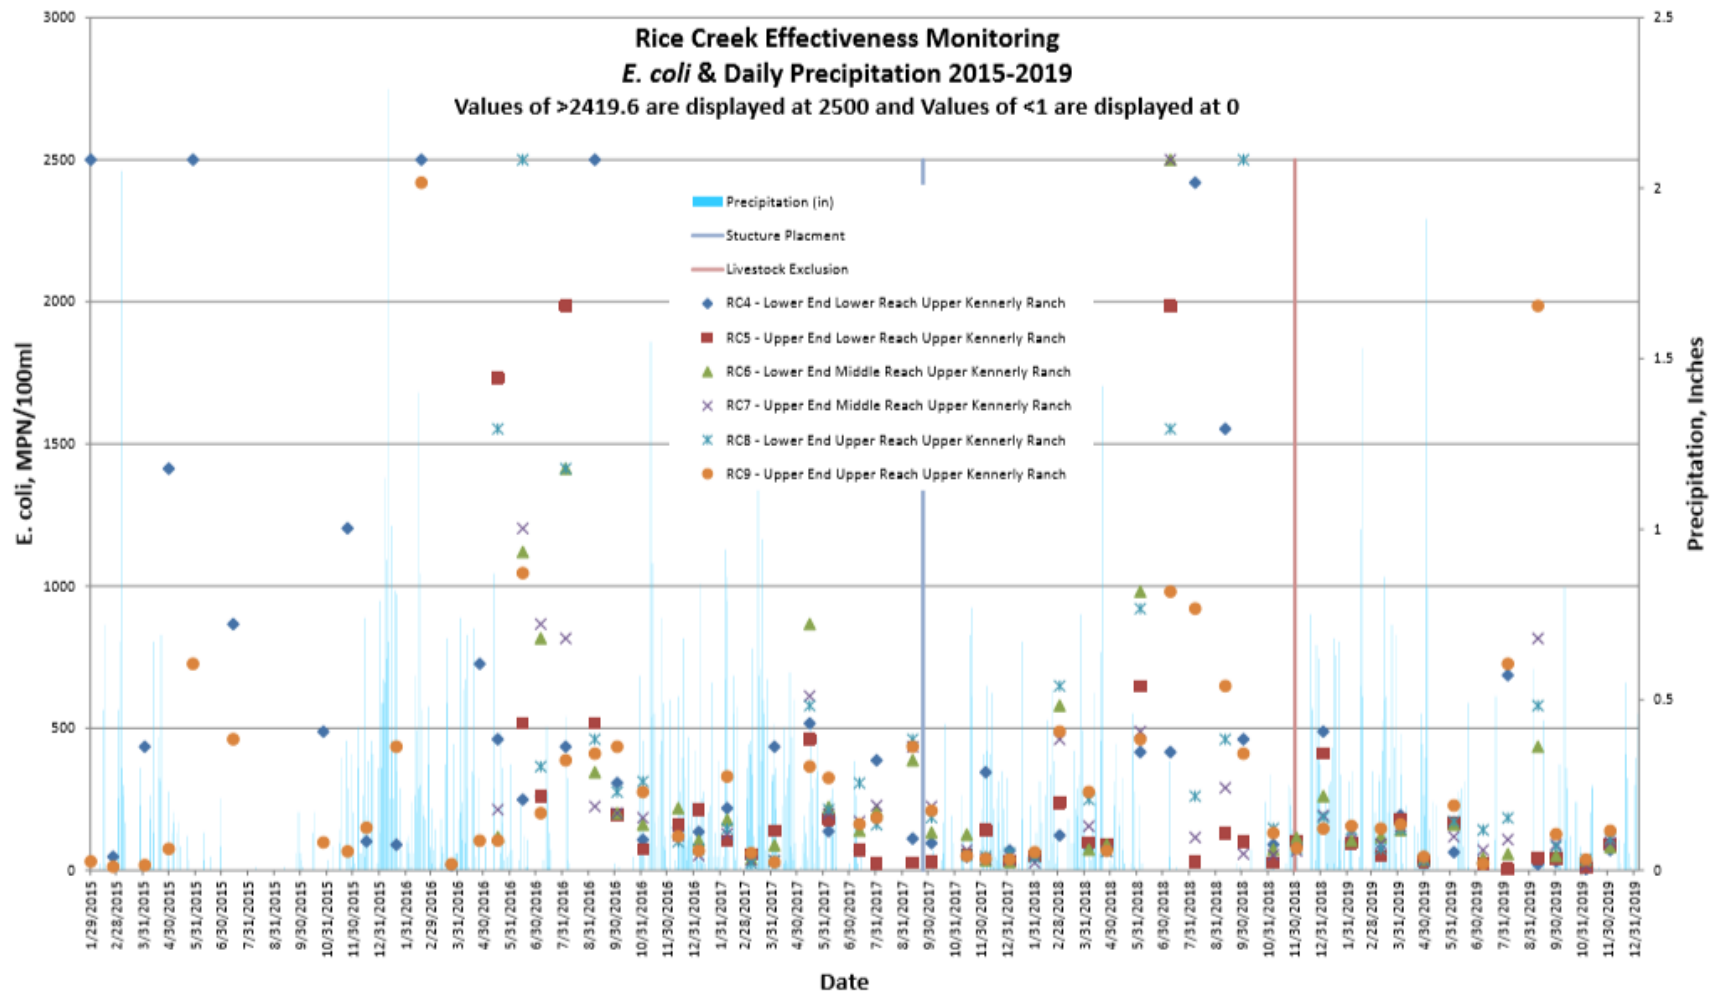
**Rice Creek Effectiveness Monitoring
E. coli & Daily Precipitation 2015-2019**
 Values of >2419.6 are displayed at 2500 and Values of <1 are displayed at 0
