**FINAL REPORT**  
**OWEB GRANT 209-2021-7205**  
**Wolf Creek Basin Restoration Monitoring-EM**

March 2013

**Partnership for the Umpqua Rivers**

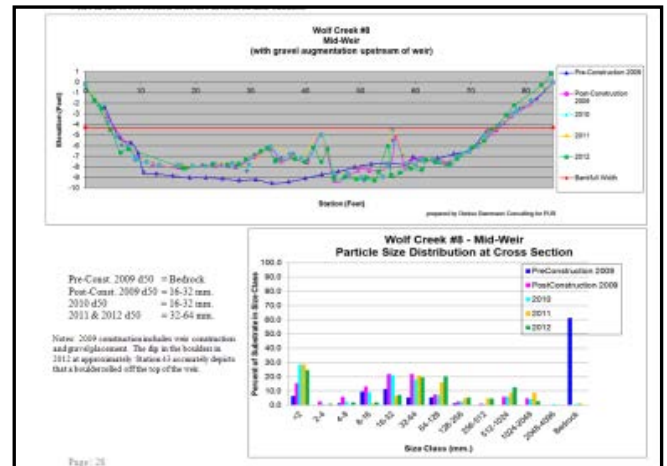
Example cross-section & pebble count chart

Appendix C: Figures 6-13 display annual cross-section profiles and pebble counts at two locations for each weir for the 2009-2012 time period.

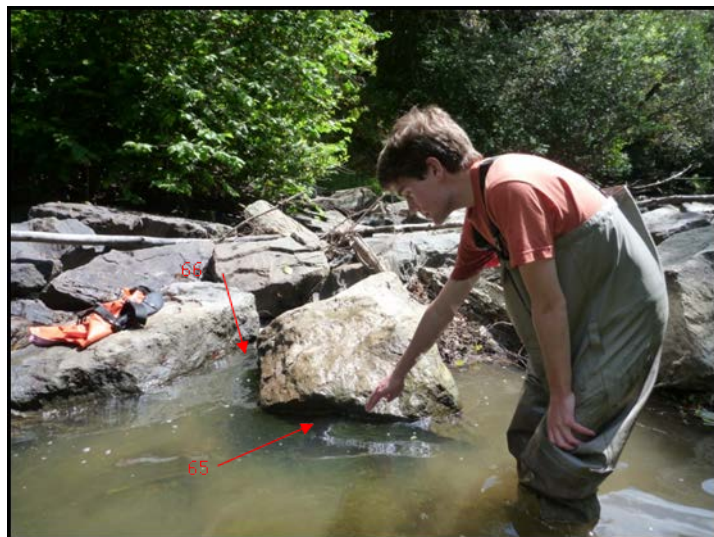
Photo 2: Weir 9 Upstream Logger Sites 65 & 66

The temperature data associated with Weir #9 also appears to be quite uniform, suggesting negligible influence from the weir. Unit 18 was found close to coming out of the water when a field audit was performed on 8/28/2012. The logger was tied to a small rock so field personnel turned it over thus placing the unit face down into the substrate. This placement may account for the lower temperature on 9/7/12. It is of interest to note the data from Unit 66 to be slightly warmer than that of Unit 65. Unit 66 was buried in 2" of sand in a narrow chute between two boulders where the water was rapidly moving through the chute. Unit 65 was placed just upstream in front of the right boulder. (See Photo #2 to right.) Typically buried units have a damped thermal response and lower maximum temperatures. It may have been possible that long-wave radiation from the two opposing boulders created an oven-like effect that affected Unit 66 even though it was slightly buried in the sand. Unit 65 did not have the benefit of the "oven" effect.

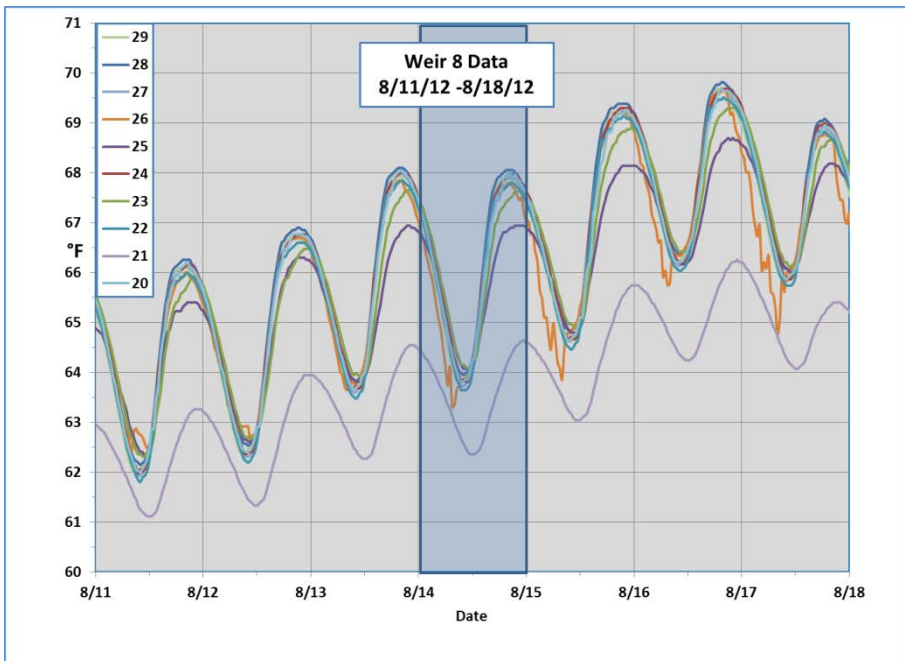
Figure 17: Weir 8 Temperature Charts, Early and Late Season, during Steady State Summer Weather Conditions 2011 & 2012

Appendix D: Figures 17-20 (Weirs 8-12) show the stream temperature seven day plots for the “steady-state” periods selected for this analysis. The shaded section in the plot area represents the time interval selected for detailed analysis.

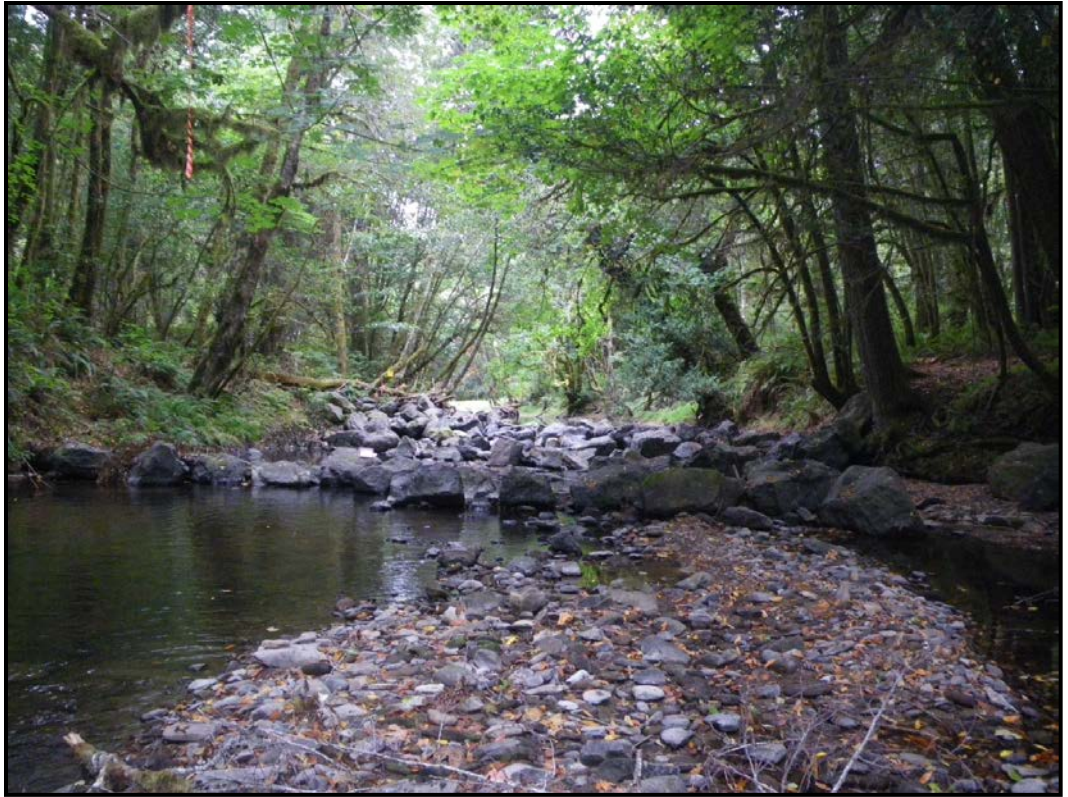
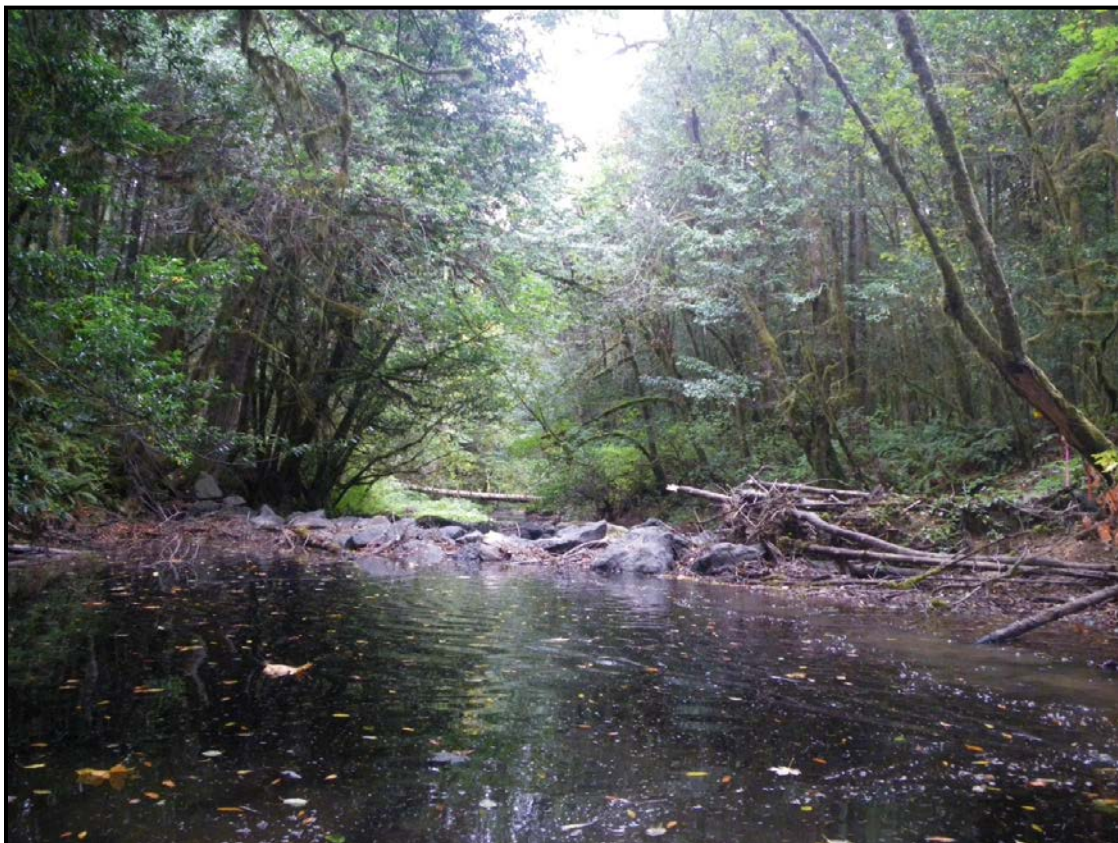
**Photo #11:**  
Weir #8 from  
downstream looking  
upstream 9/21/2012  
Low flow  
conditions
