Partnership for the Umpqua Rivers

Morgan Creek Restoration

OWEB Project # 210-2061 Project Monitoring Report – Year Three June 24, 2015

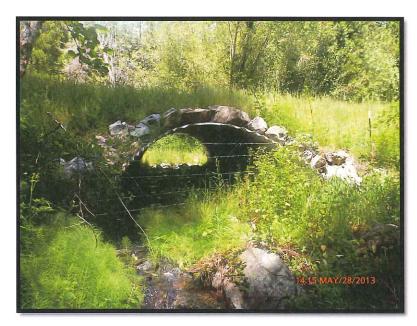
Briggs Culvert Outlet
Post-project June 2015. Vegetation, including small alders, have vegetated all the disturbed areas around the culvert replacement.
